Reducing the Risk of Life Safety Issues From Construction Defects

February 4, 2023

Case Study 1 - New Library

Case Study 2 – New Performing Arts Center

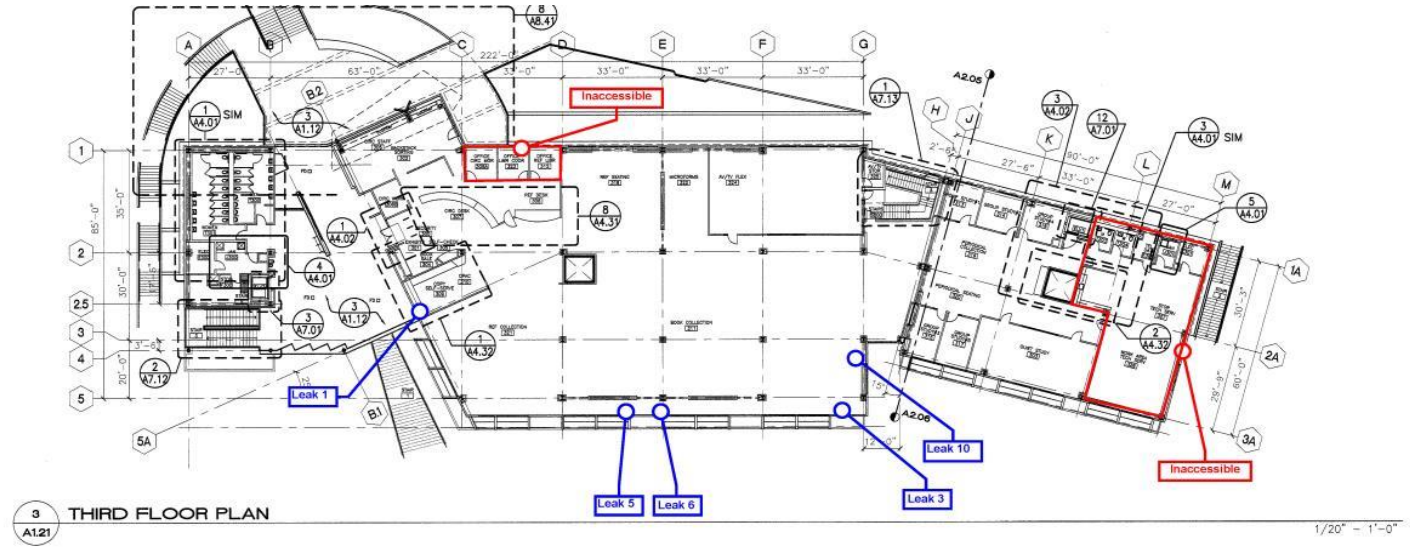
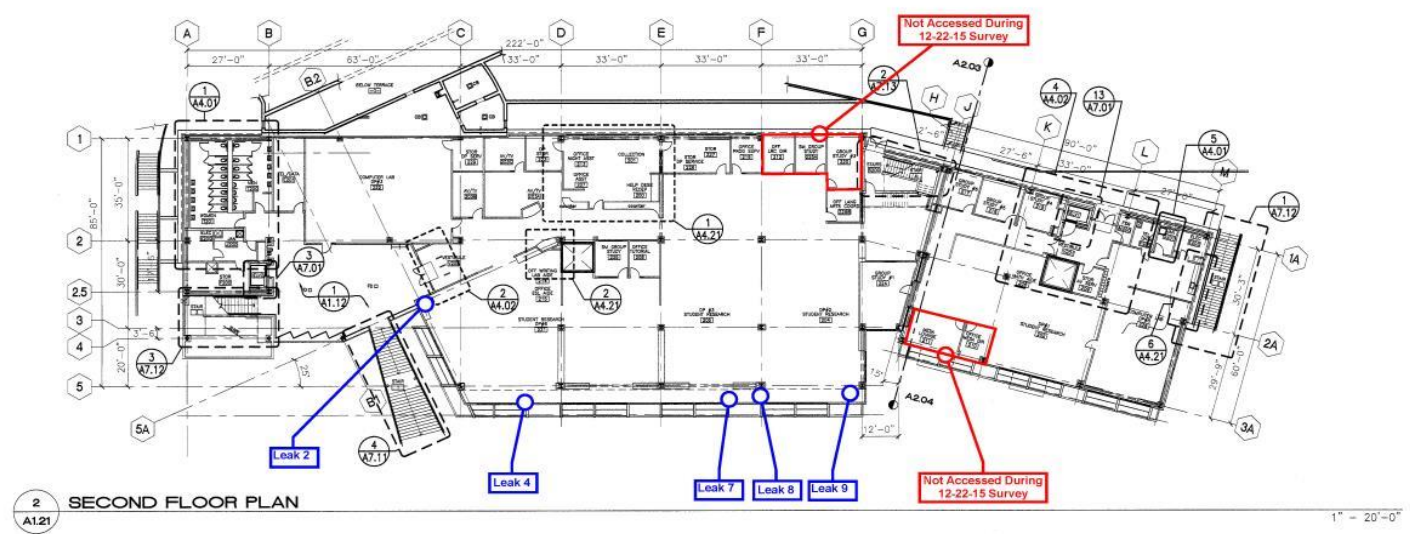
Leaks Observed During Rainstorm – 2015

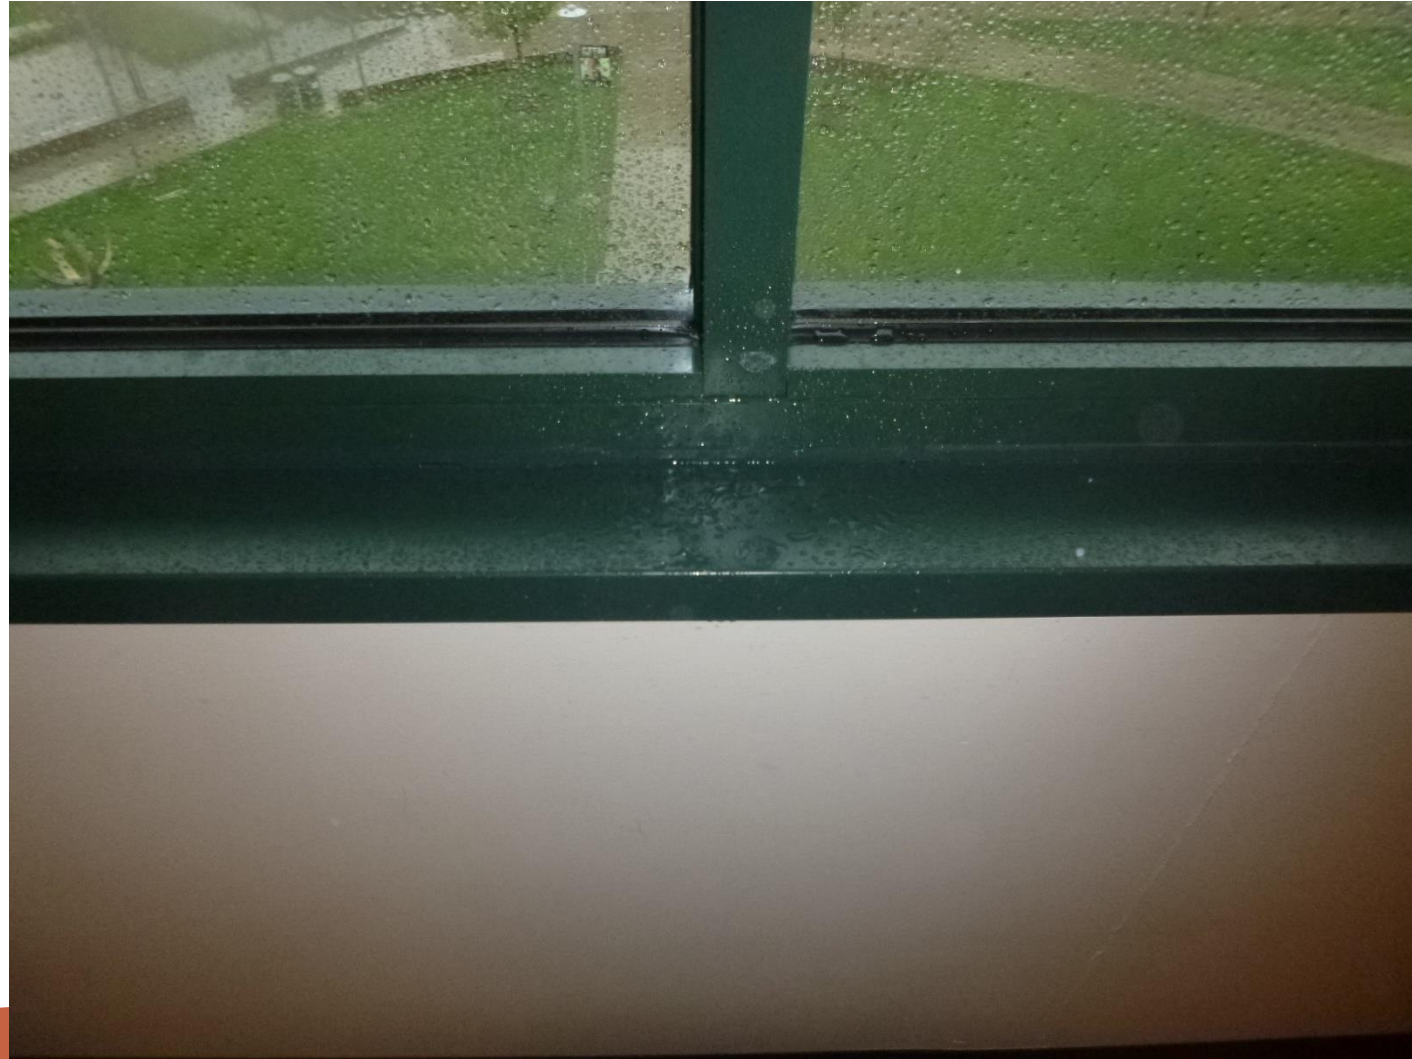
Windows Leaking During Rainstorm

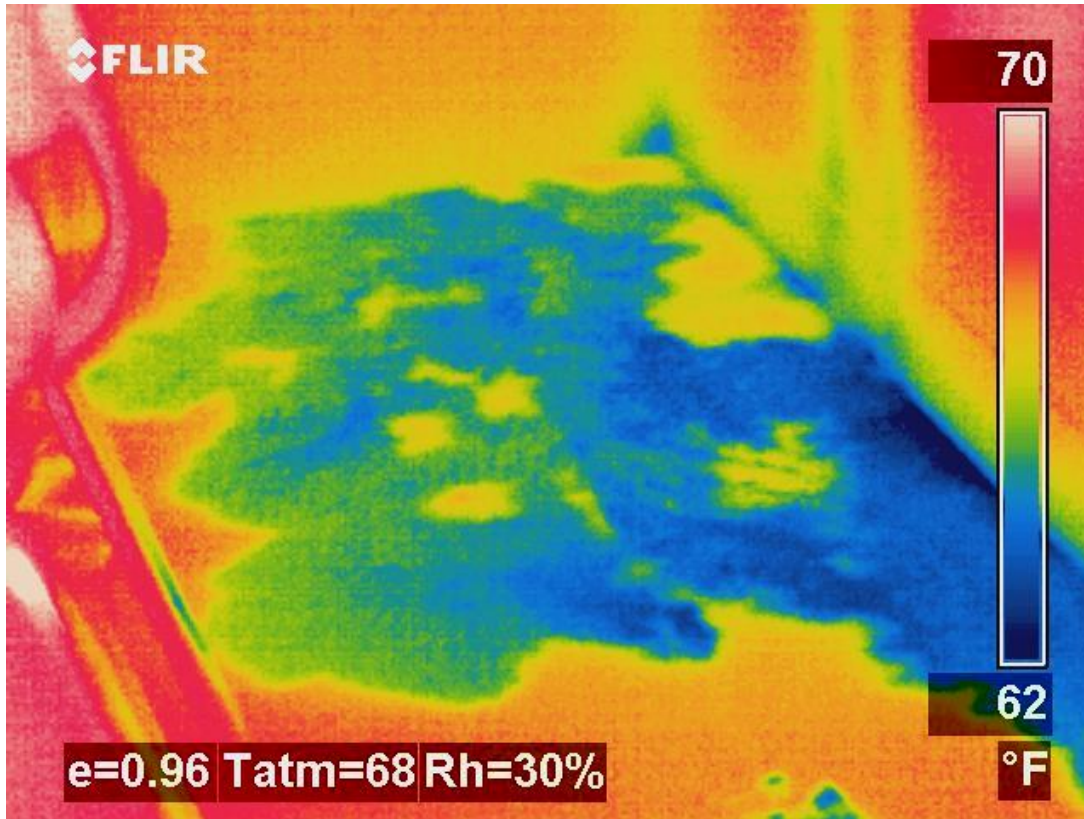
Leaks From Rain Event on IR Camera

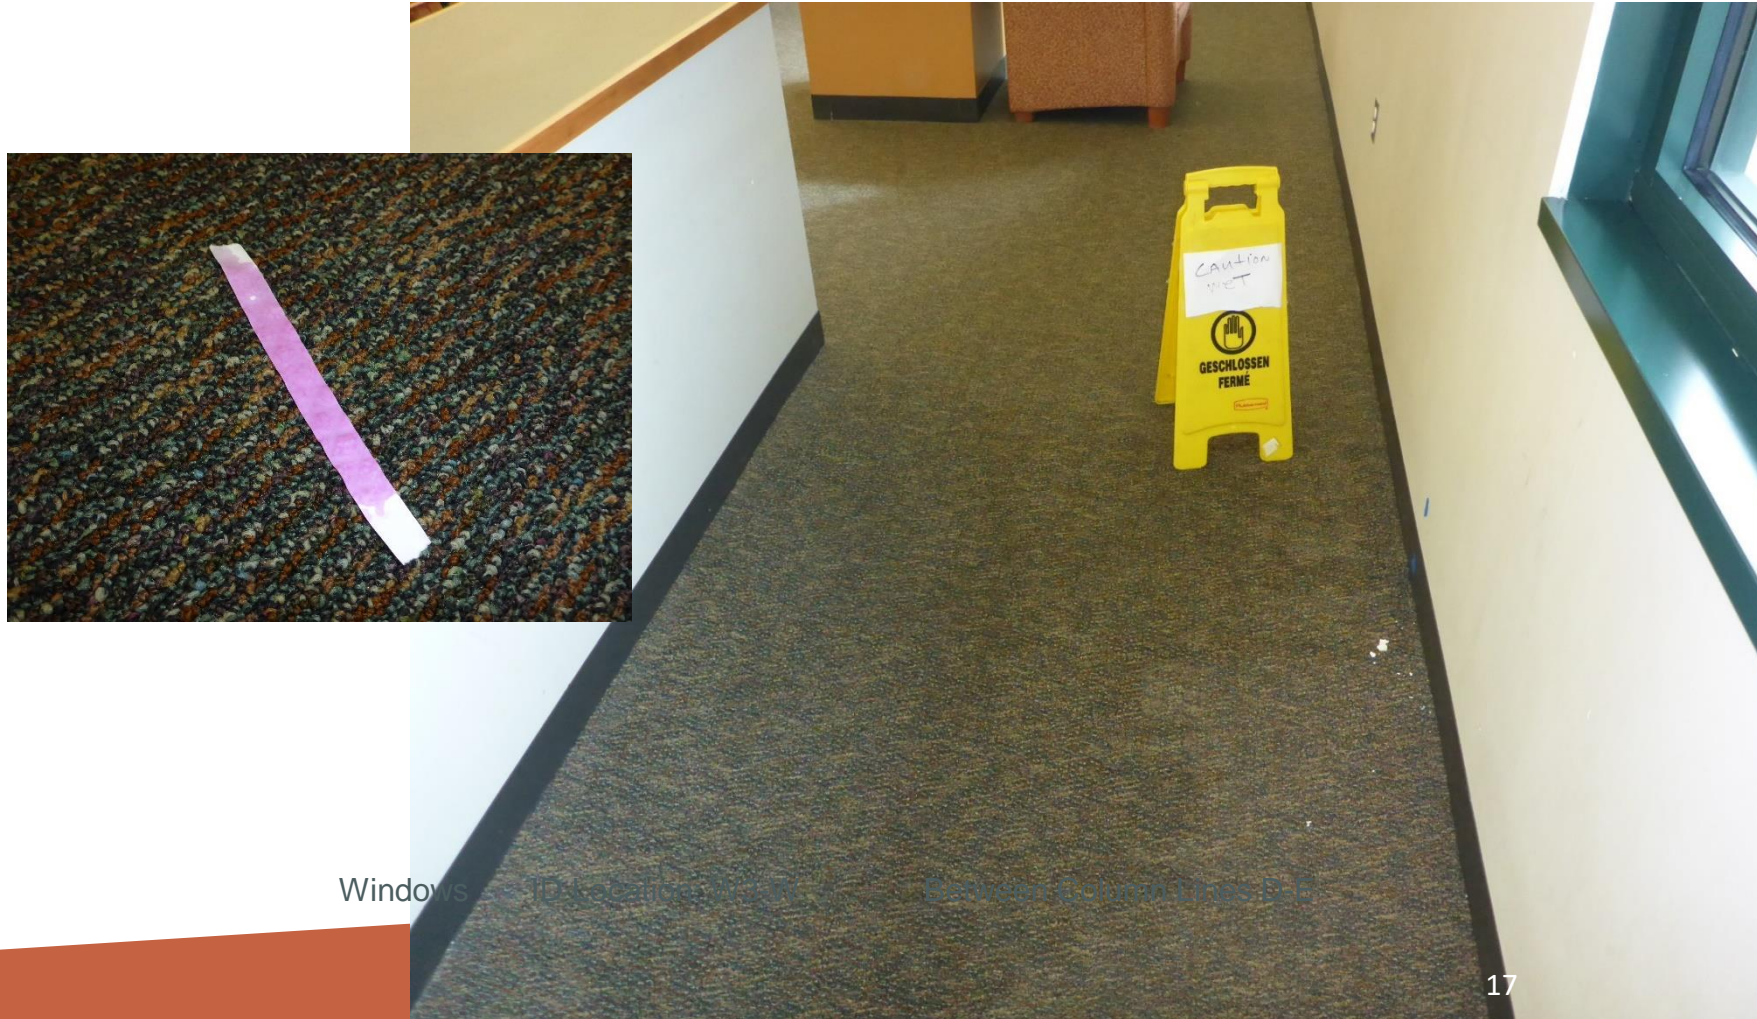
ID Location: W-111

Wet Floor, Leaks From Rain Event

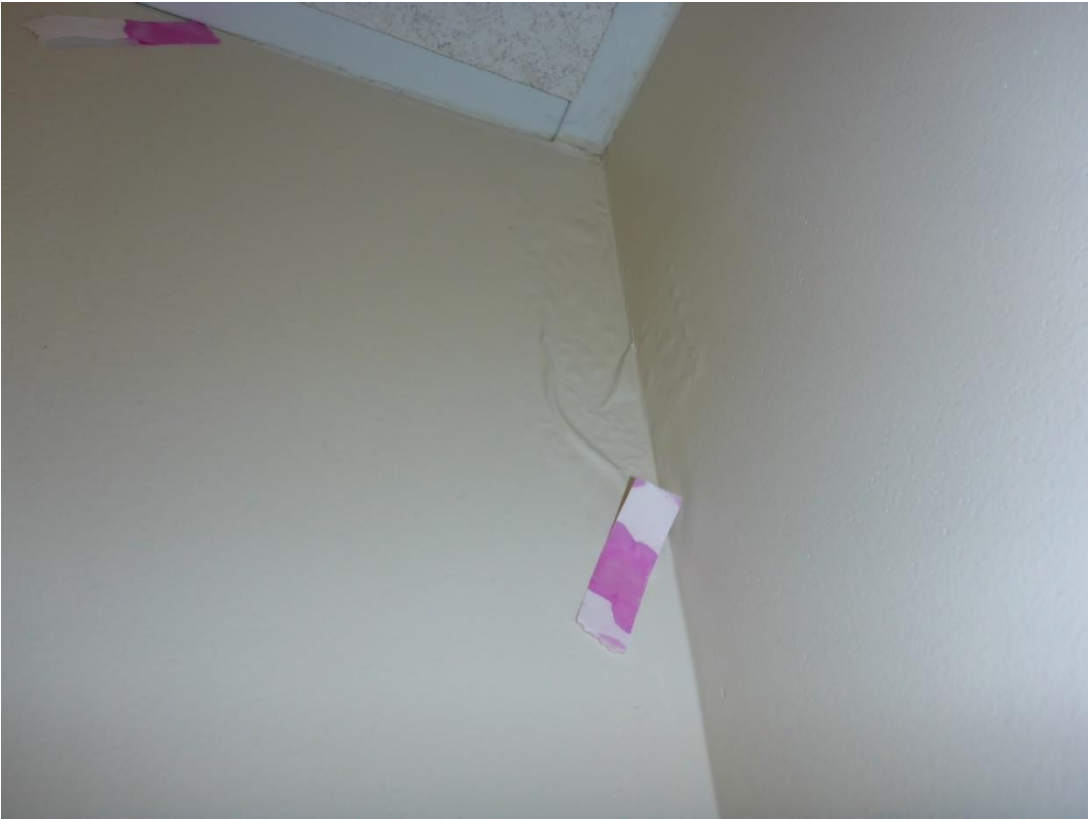
ID Location: Below Plaza Decks

Leaks Below Plaza From Rain Event

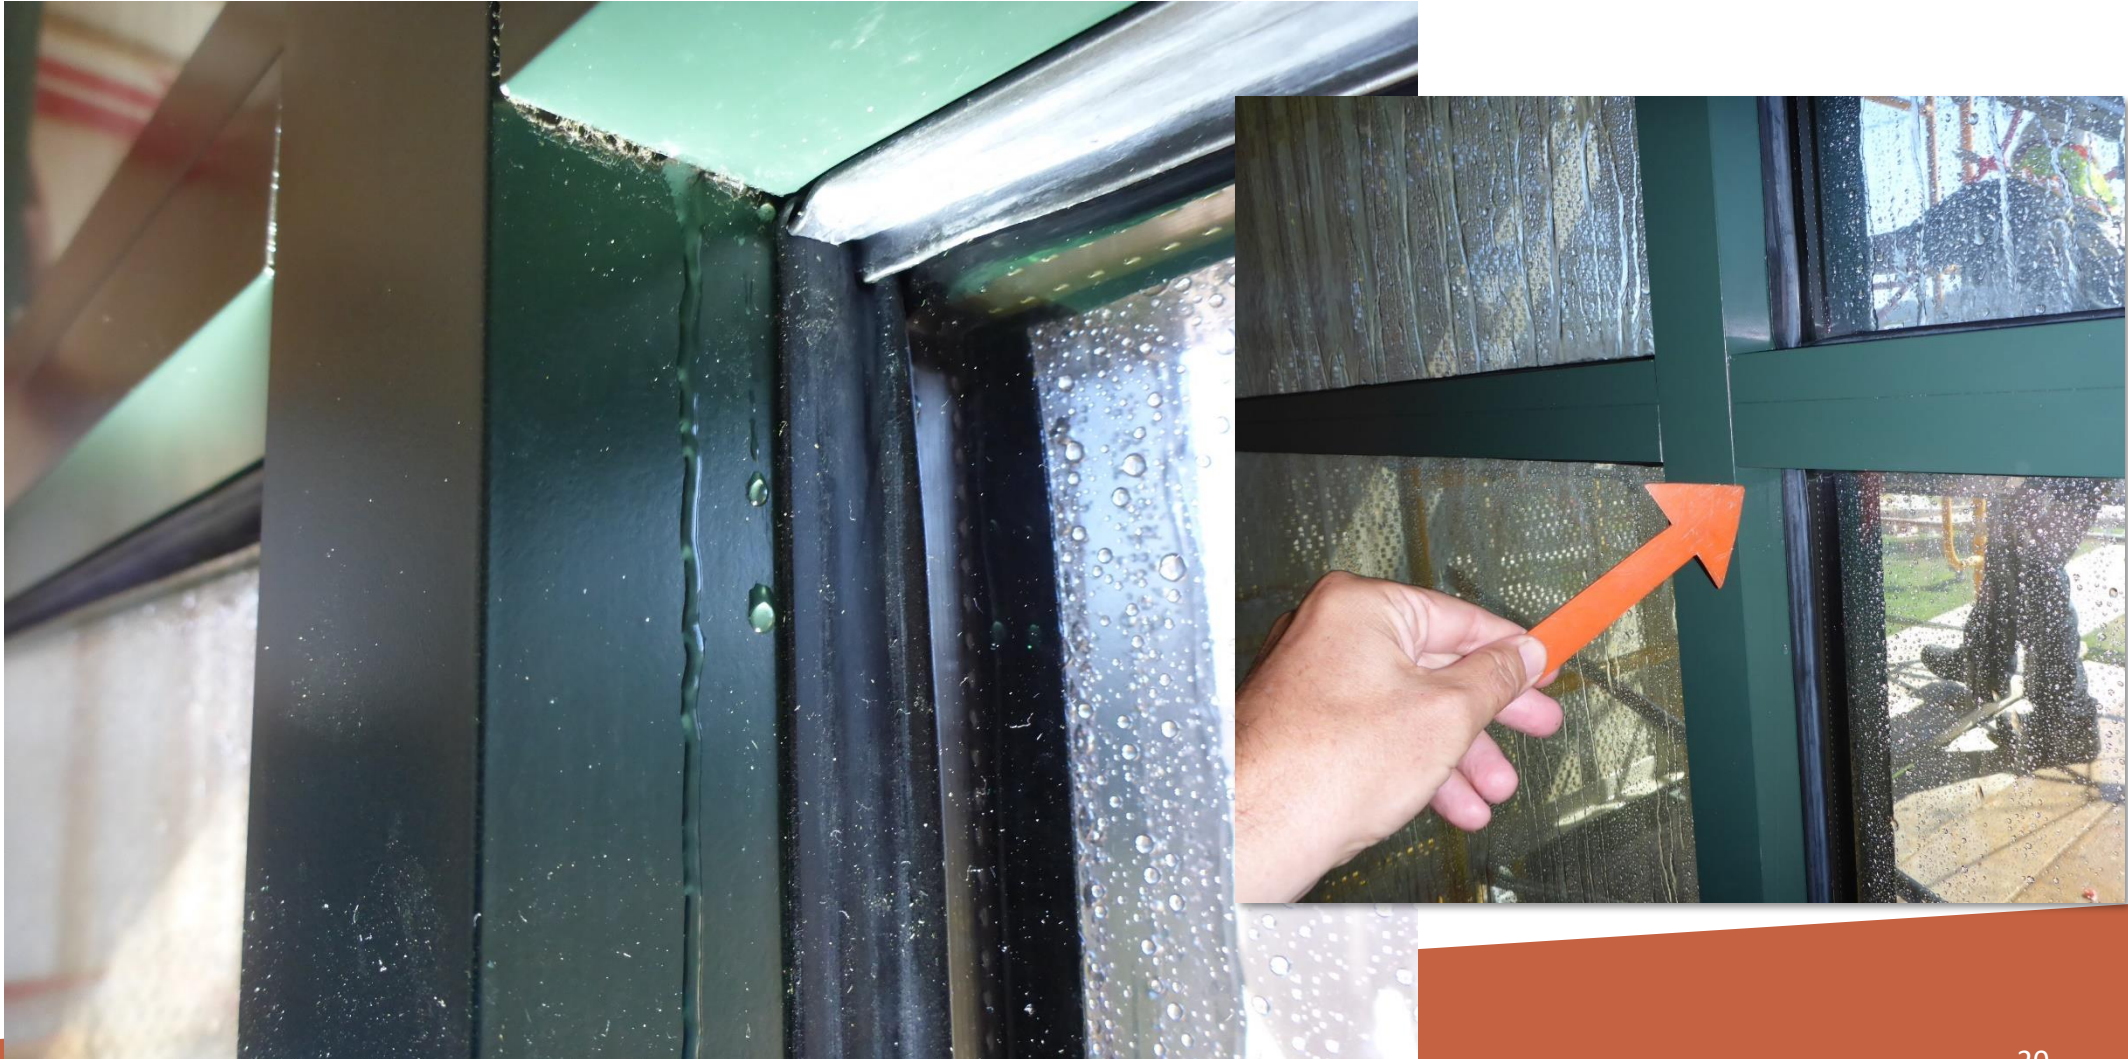
Window Leaking During Water Testing

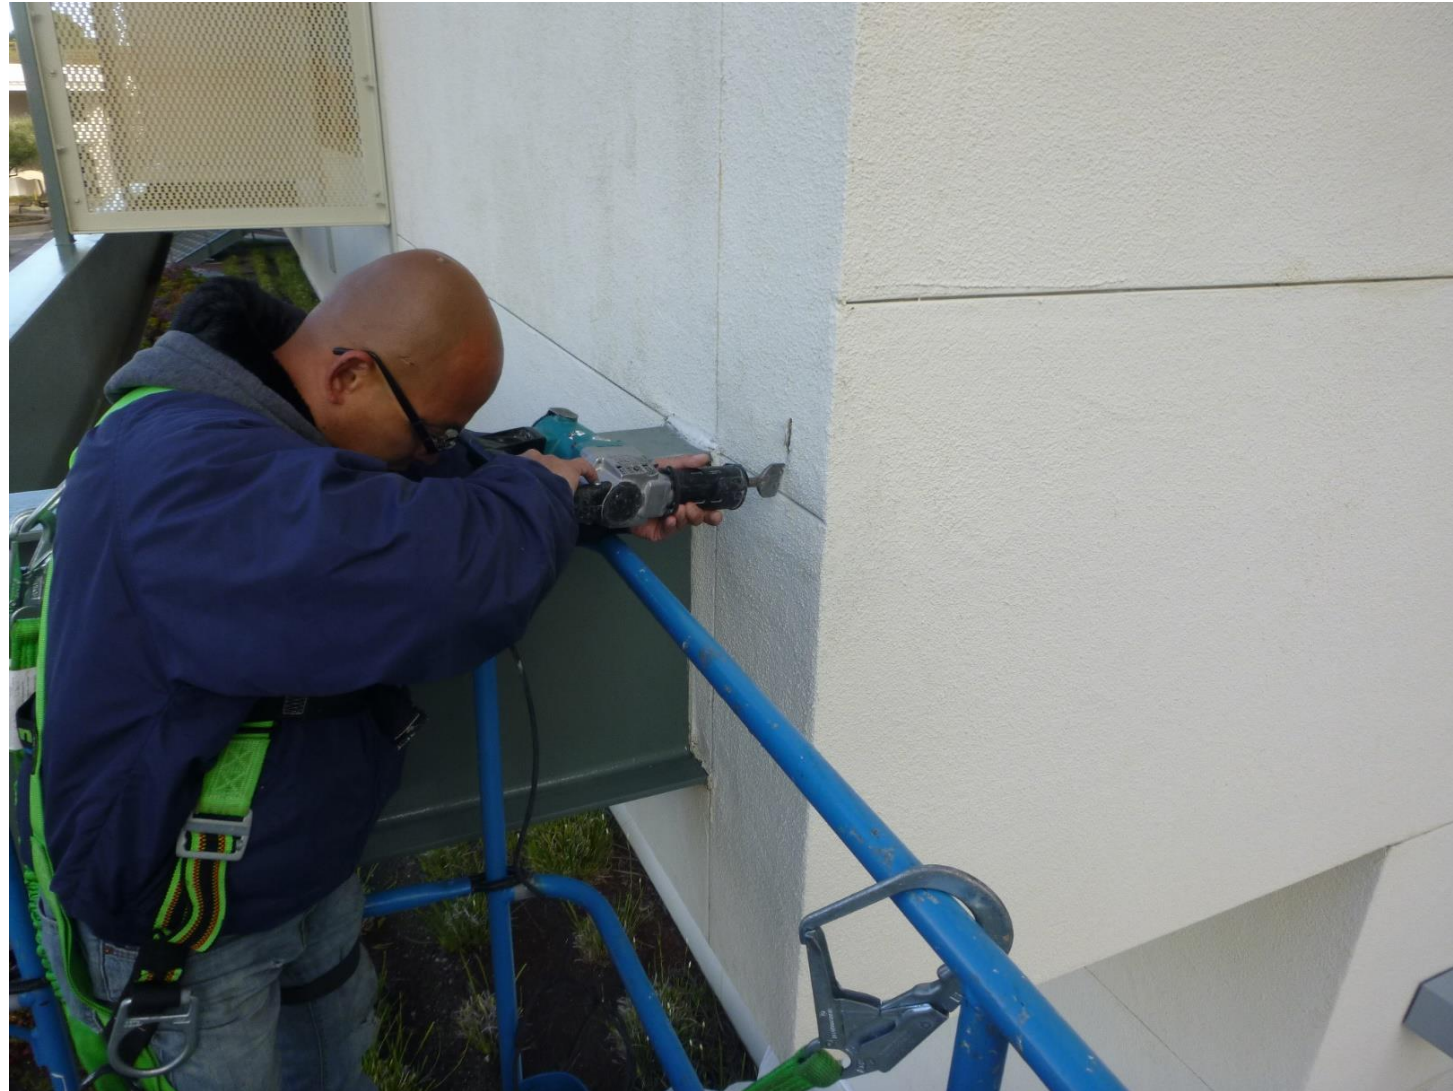
Destructive Testing of Stucco Assembly

Exterior Stucco Wall Repair

- Remove and replace 100% of the stucco assembly on the West elevation, partial South and partial North elevations
- Remove and replace window flashings and sealants
- Remove and replace sheet metal flashings at stucco penetrations and stucco accessories

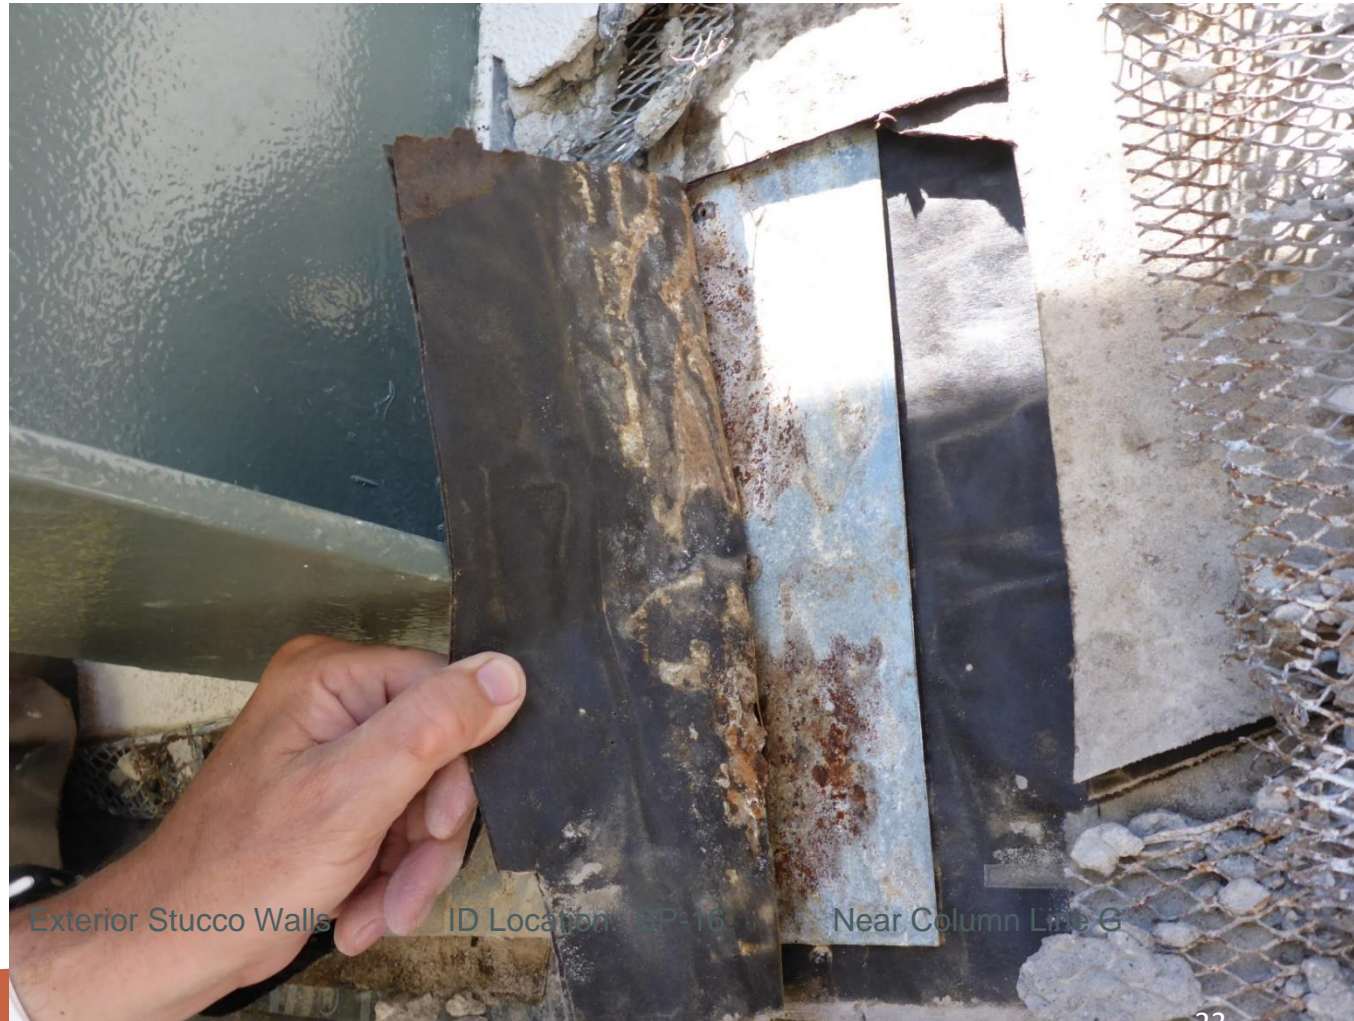
Corroded Sheet Metal Flashings

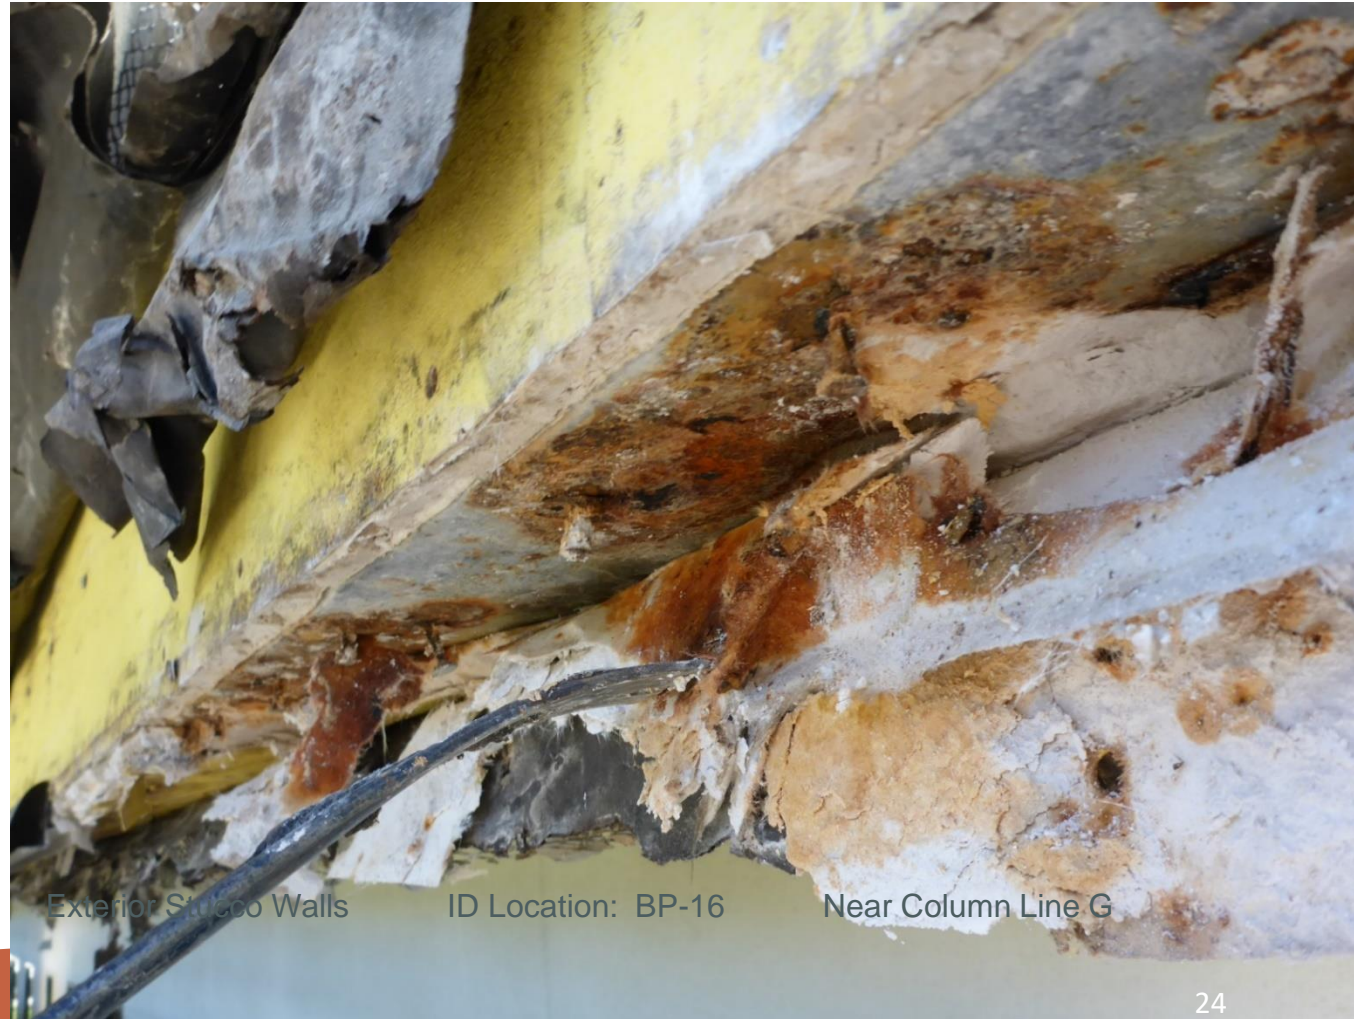
ID Location: BP-16

Water Damaged Soffit, Biological Growth

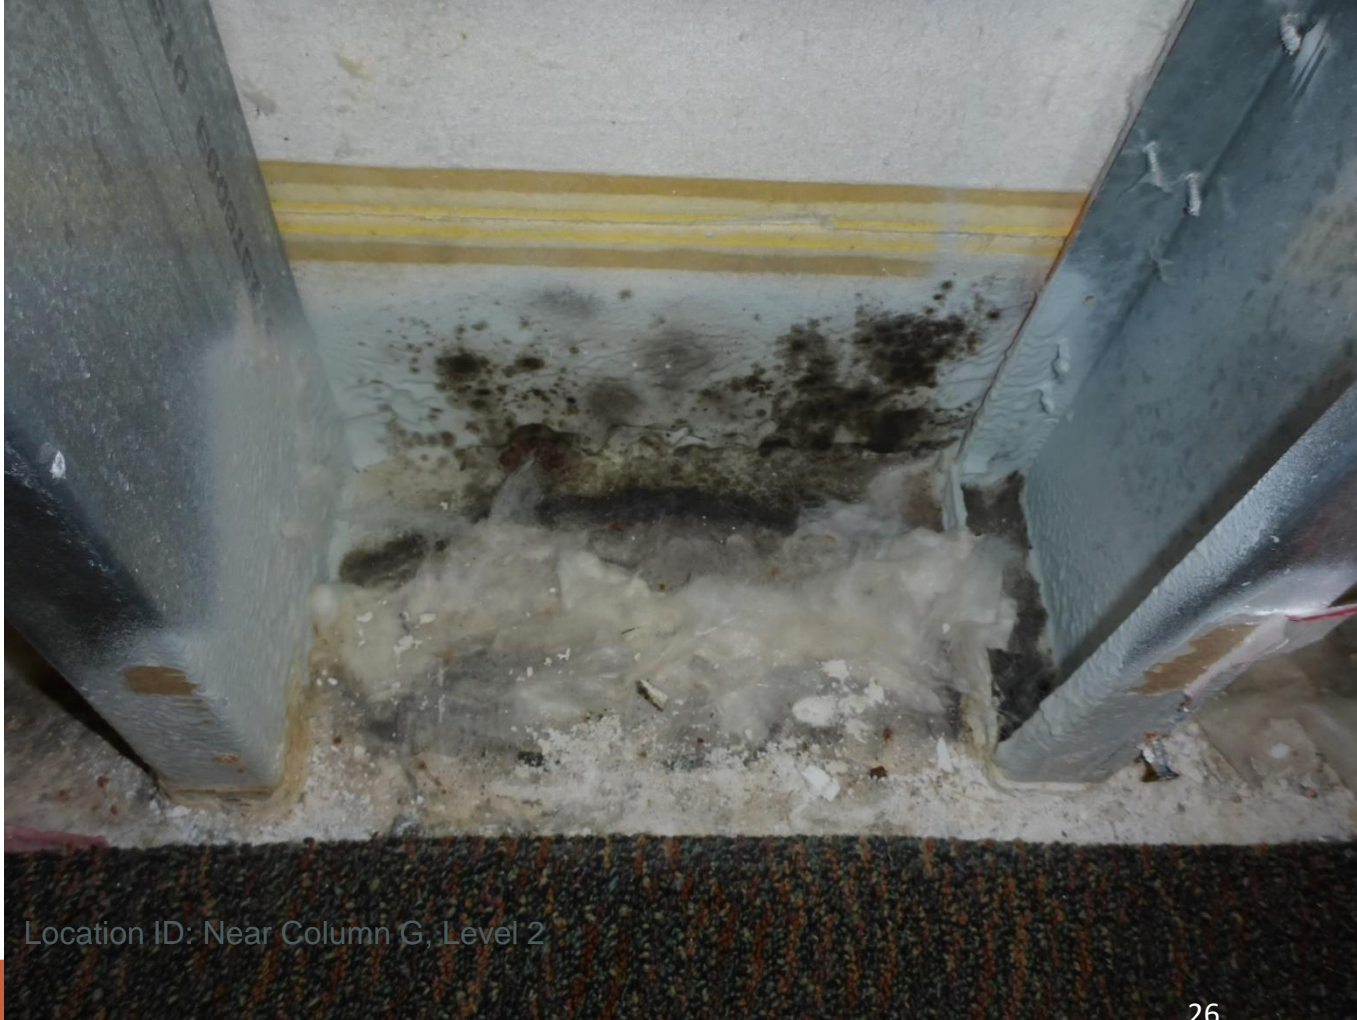
Location ID: Near Column G, Level 2

Mold Abatement Under Windows

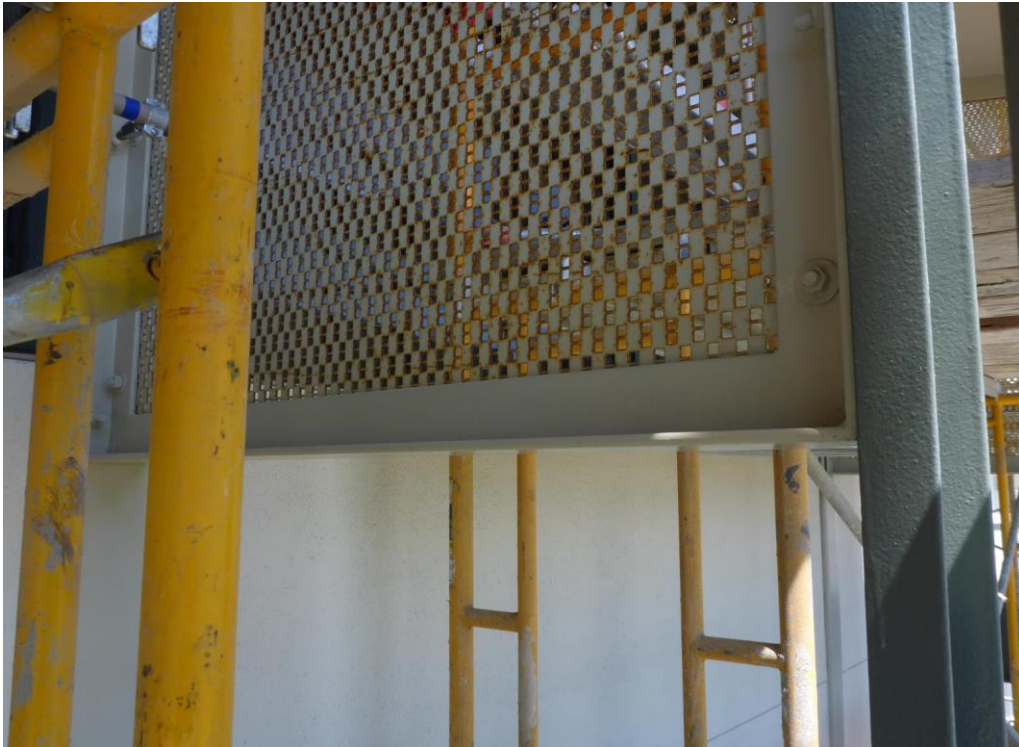
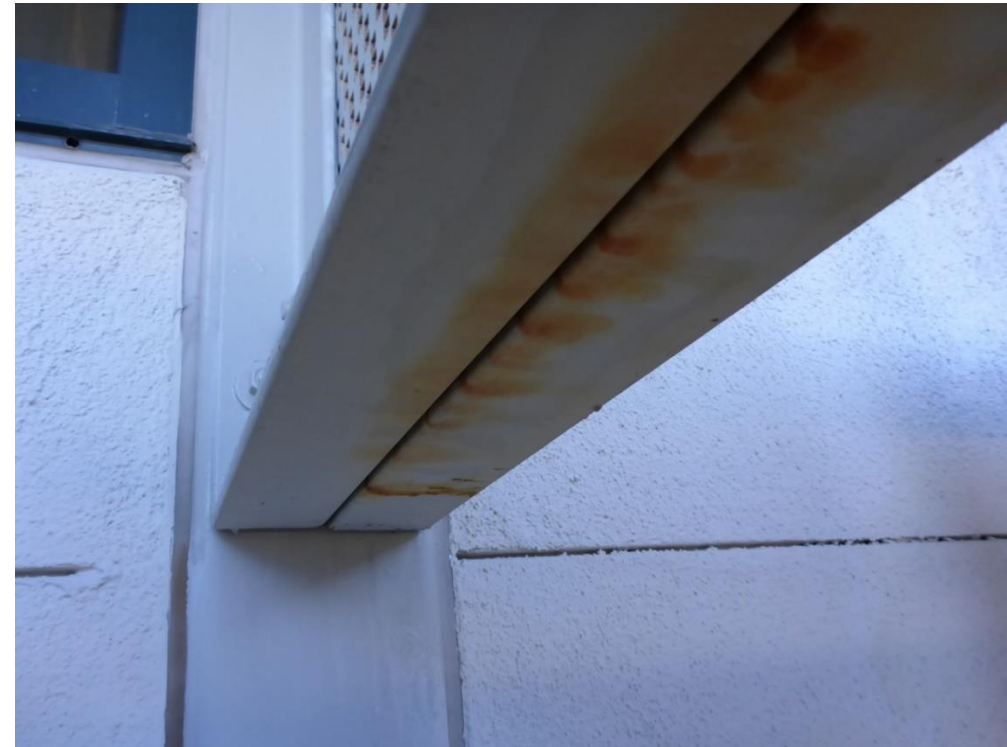
Sun shade Coating is Failing and Rusting

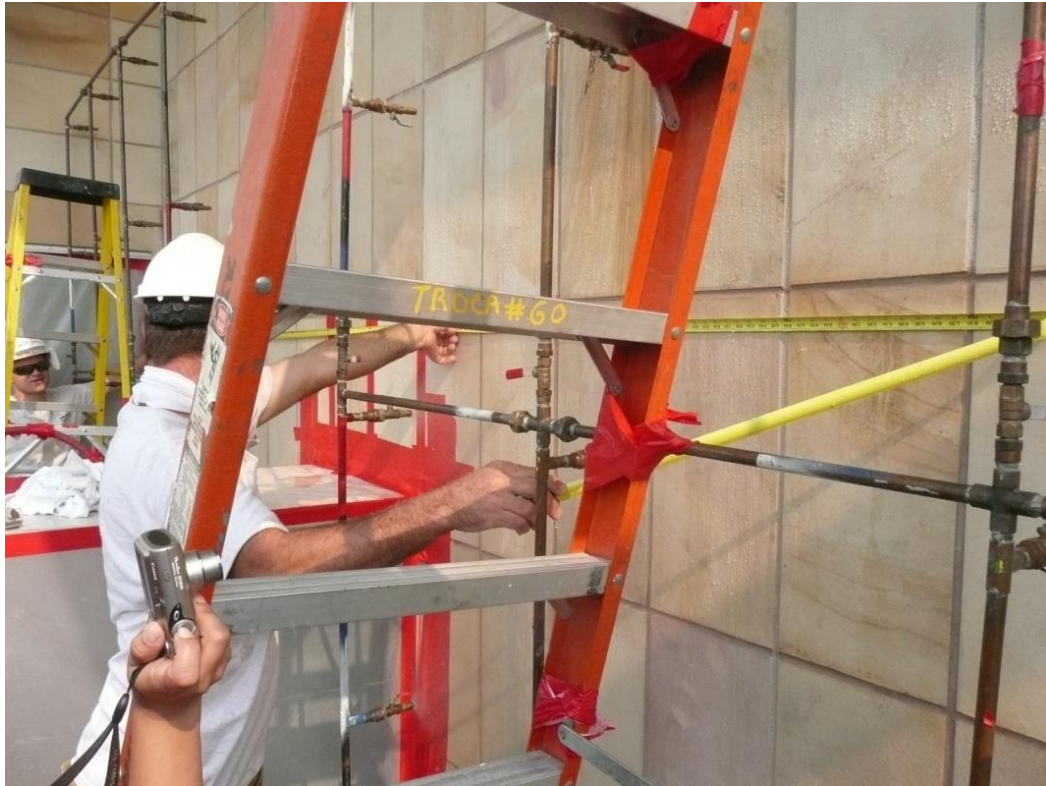
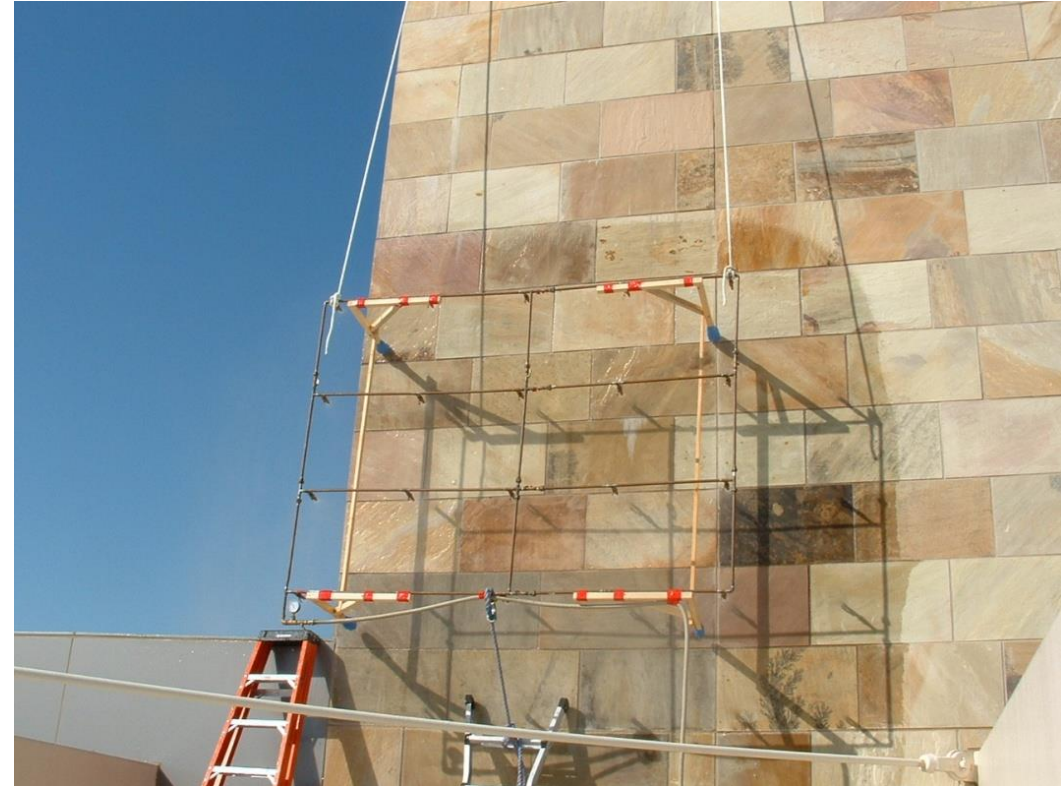
Water Testing – Leaking Stone Veneer Wall

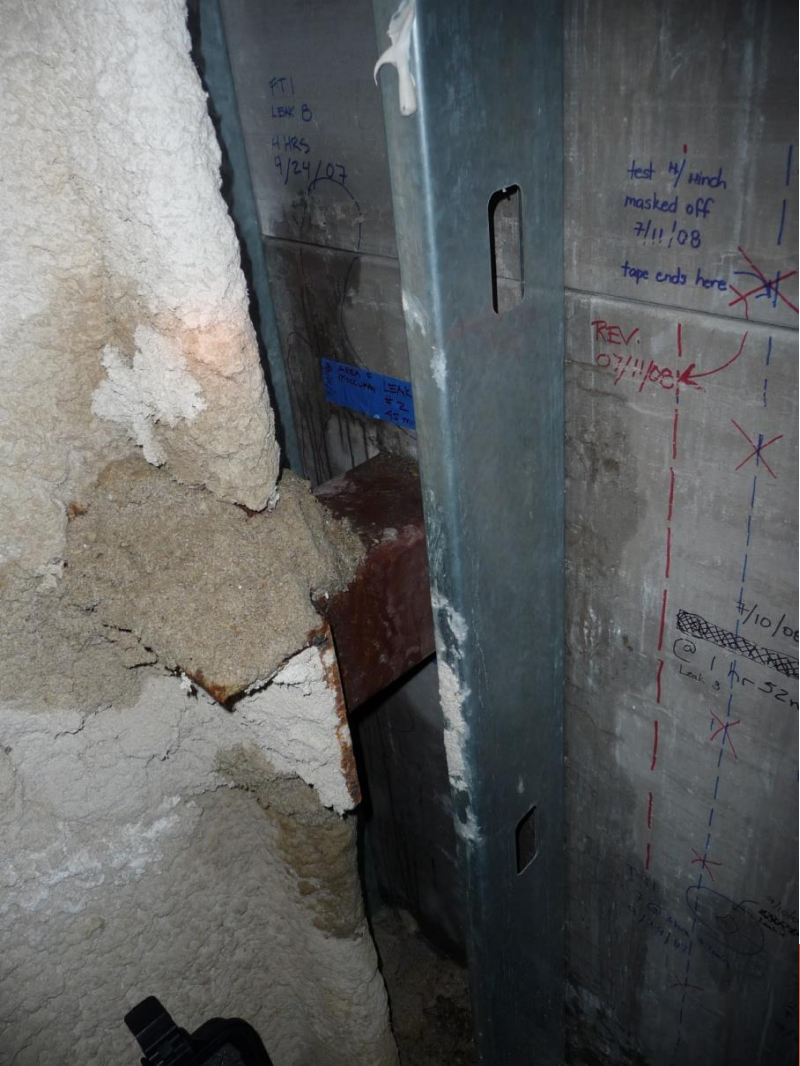
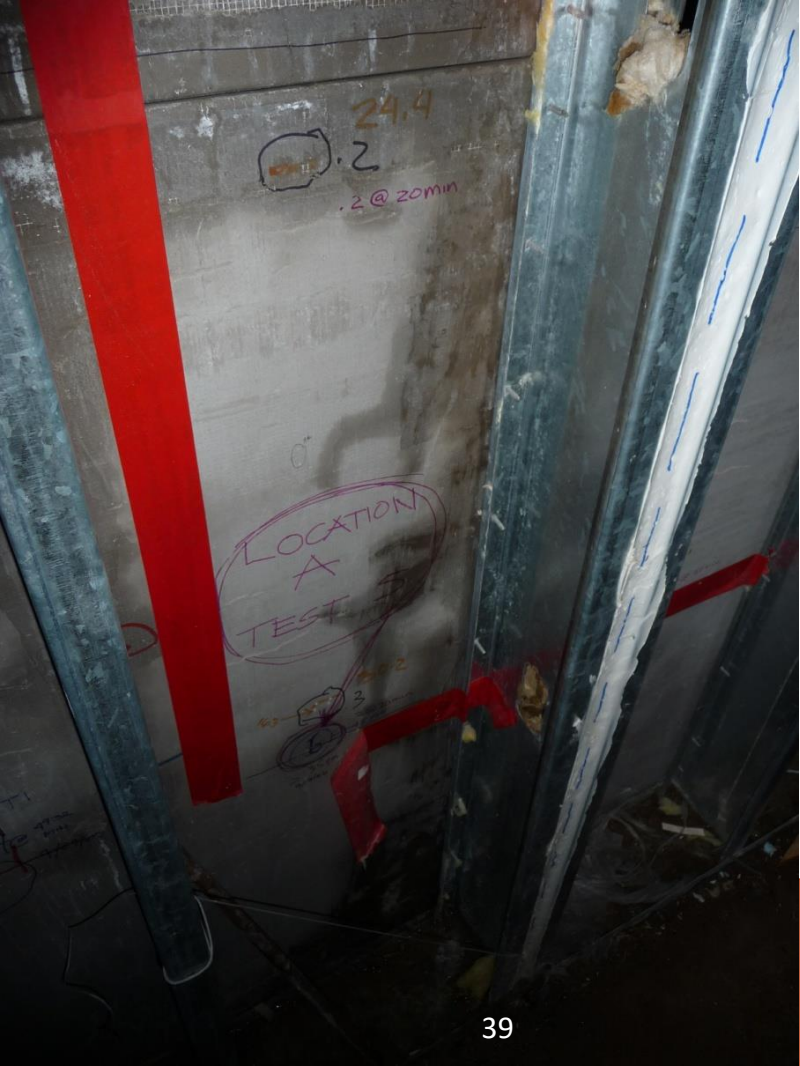
Interior Leaks Behind Stone Veneer

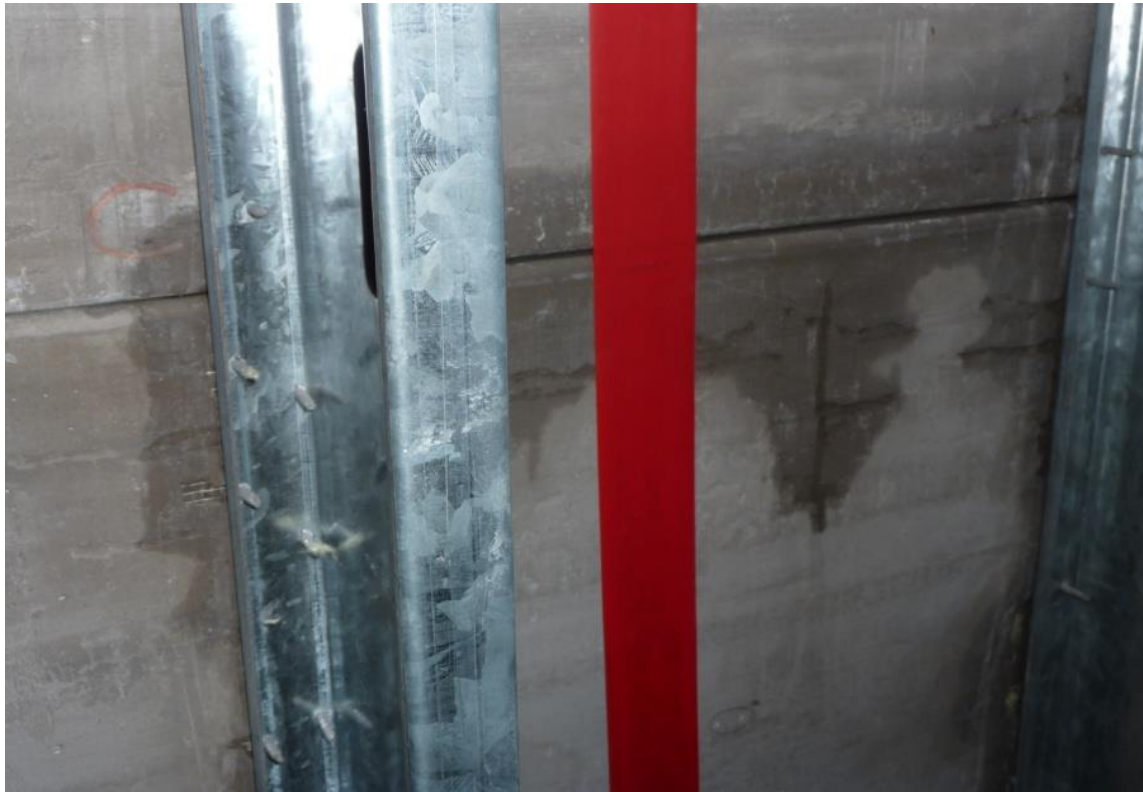
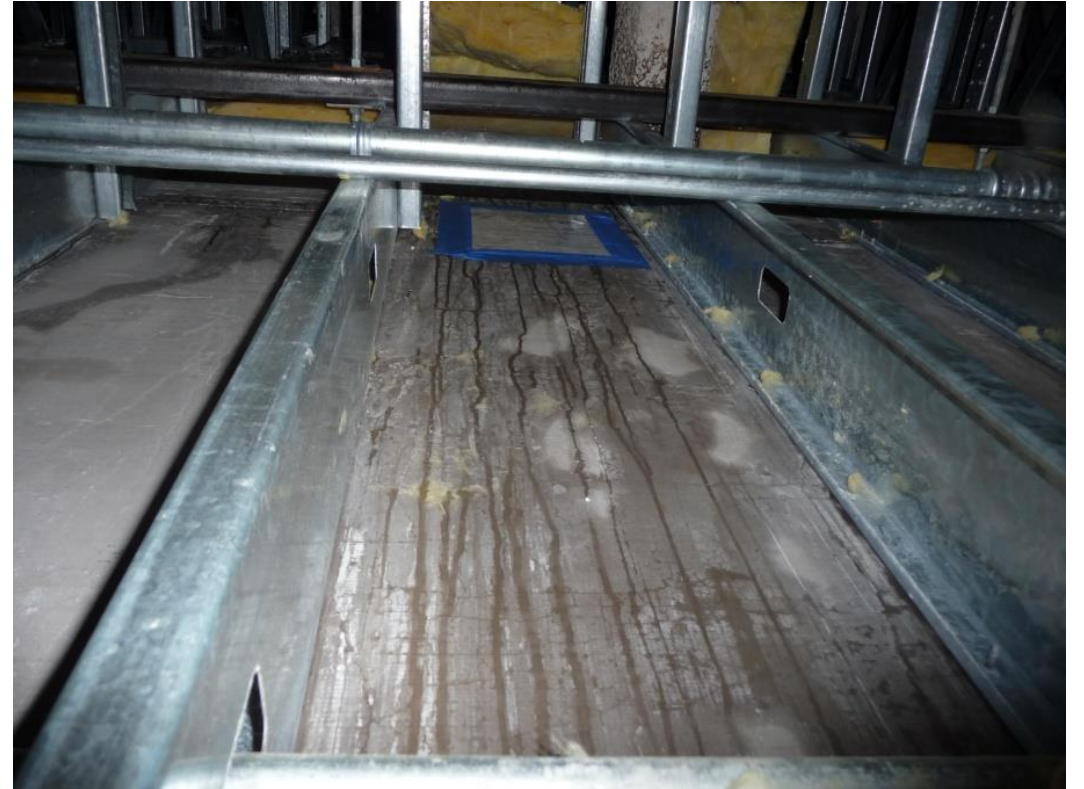
Interior Leaks Behind Stone Veneer

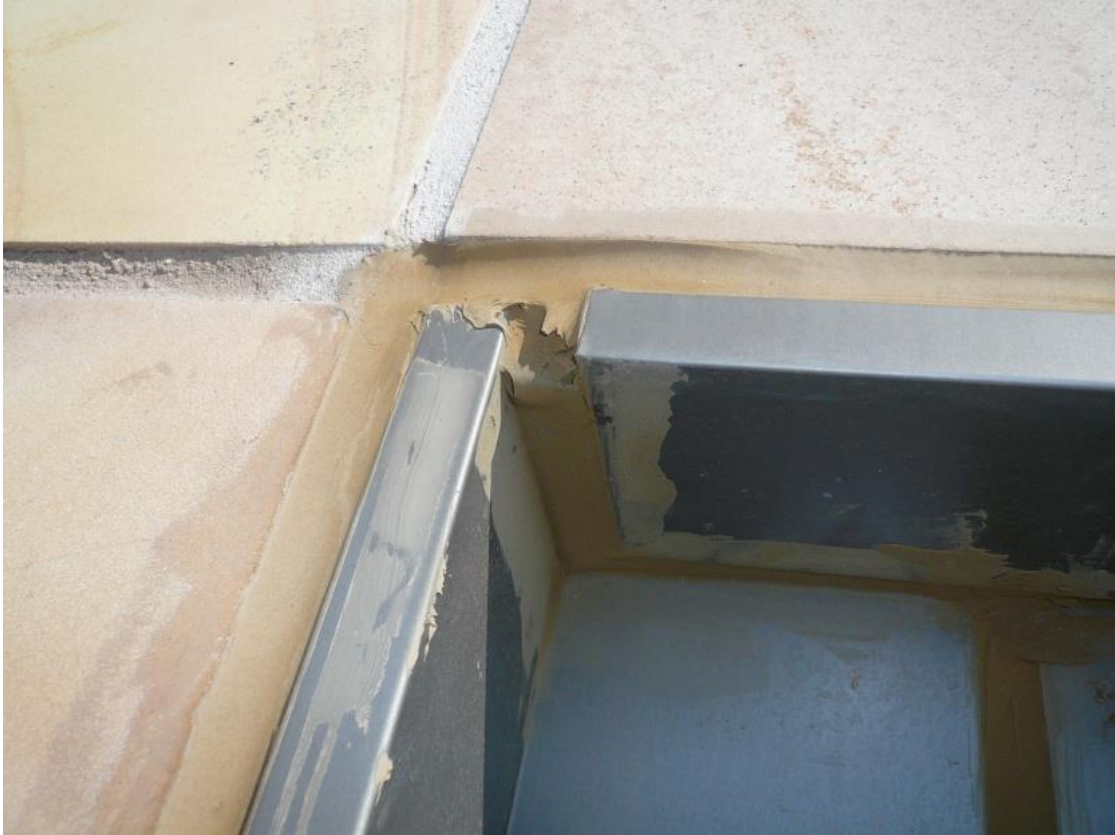
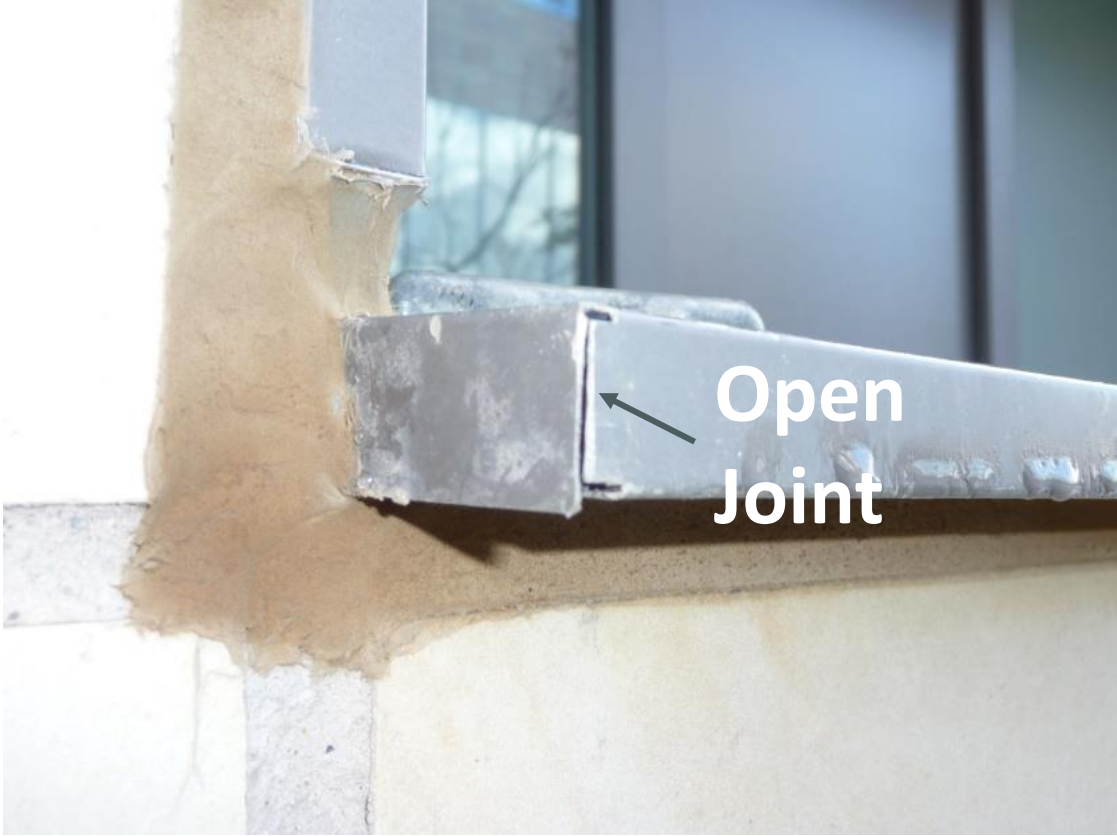
Recessed Window Visual Observations
