Reducing the Risk of Life Safety Issues From Construction Defects

February 4, 2023

Case Study 1 - New Library

Case Study 2 – New Performing Arts Center

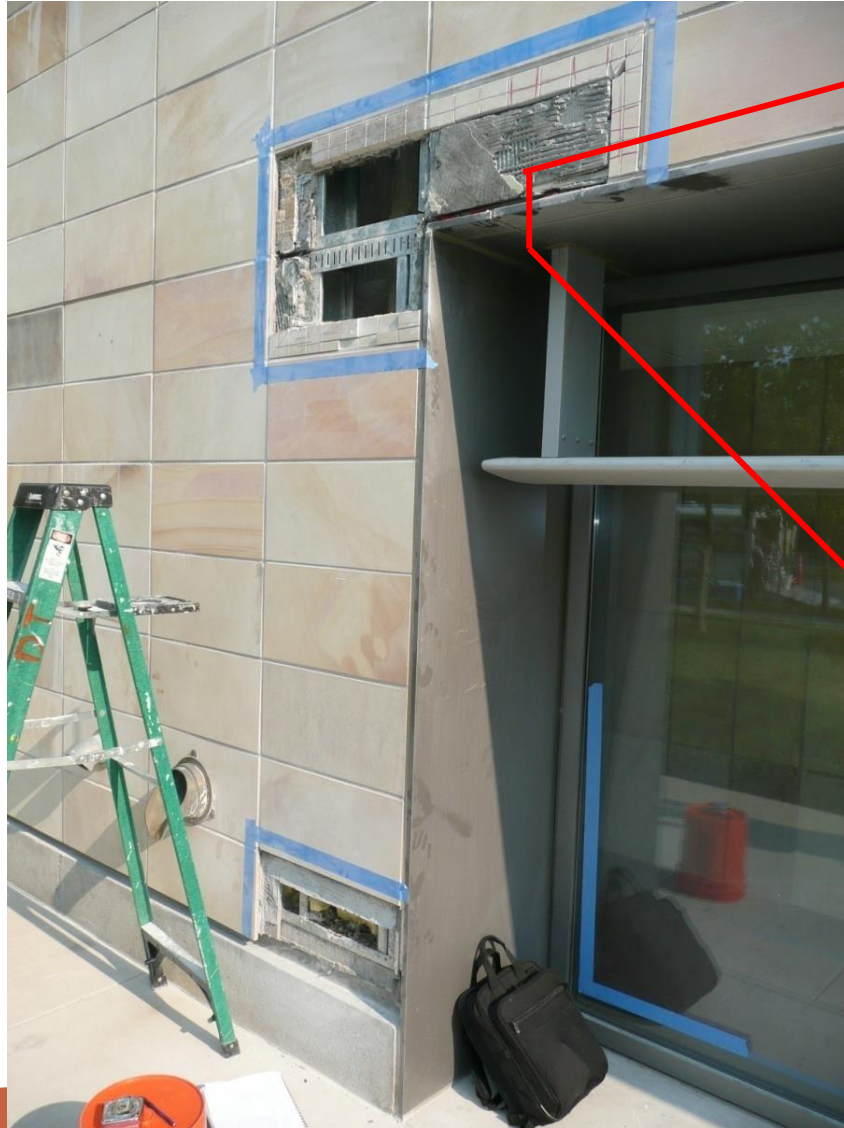
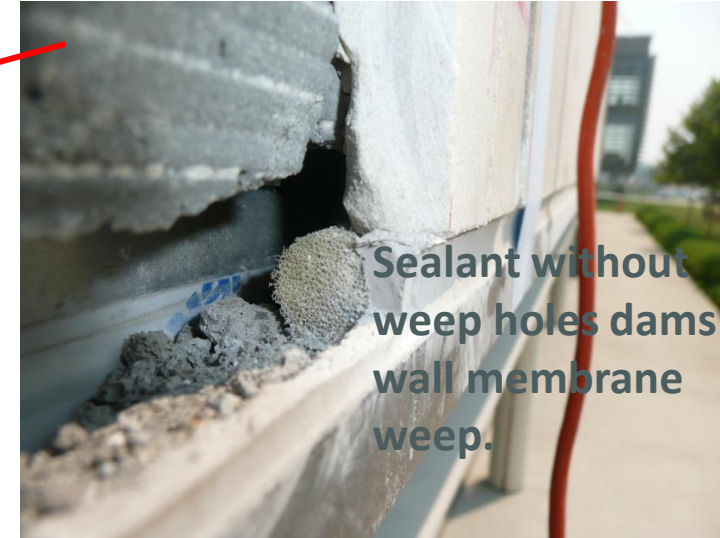
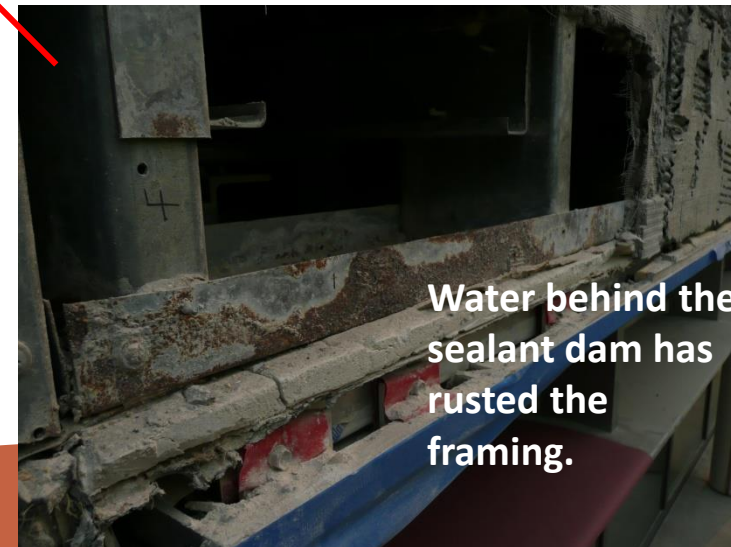
Destructive Testing Window Head Lacks Weeps

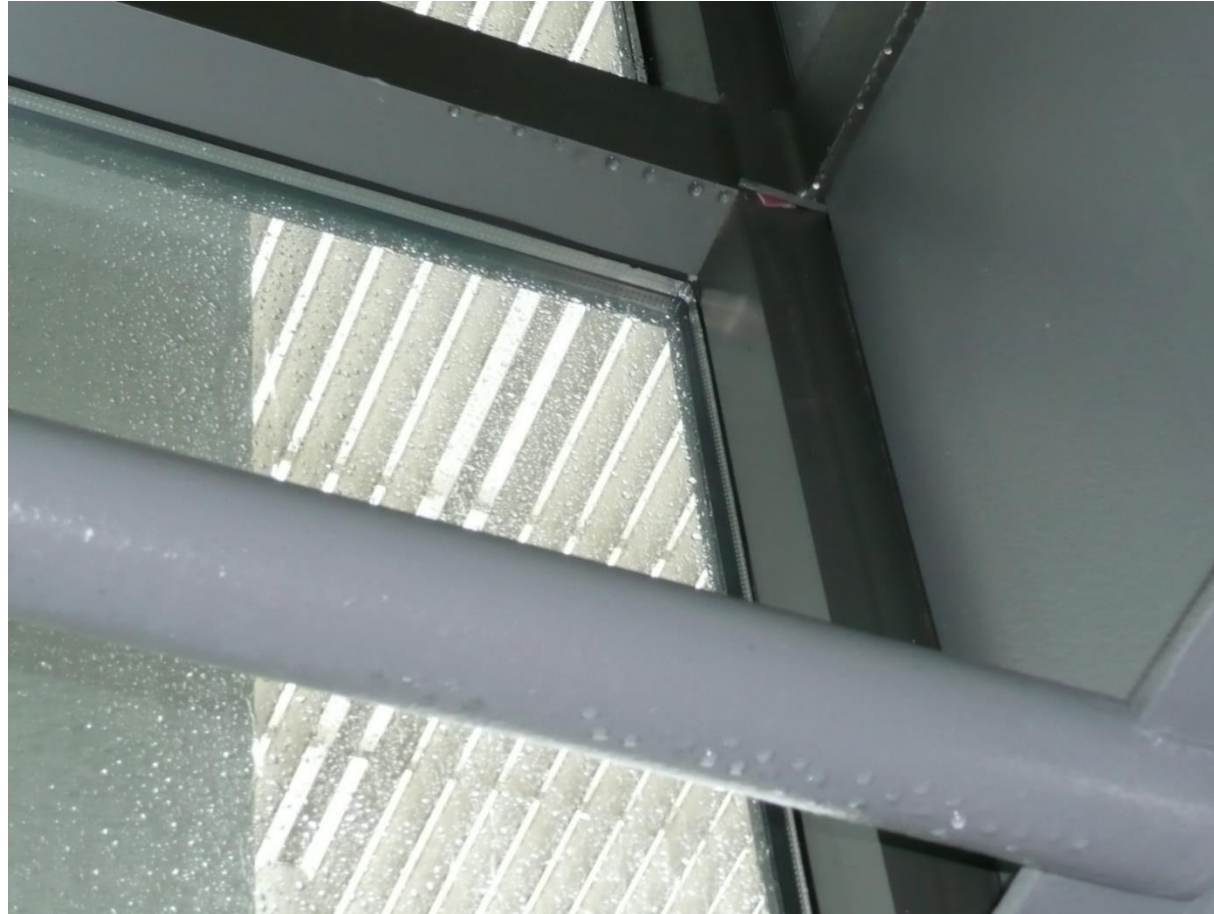
Curtain Wall Leaks at East (Front) Elevation

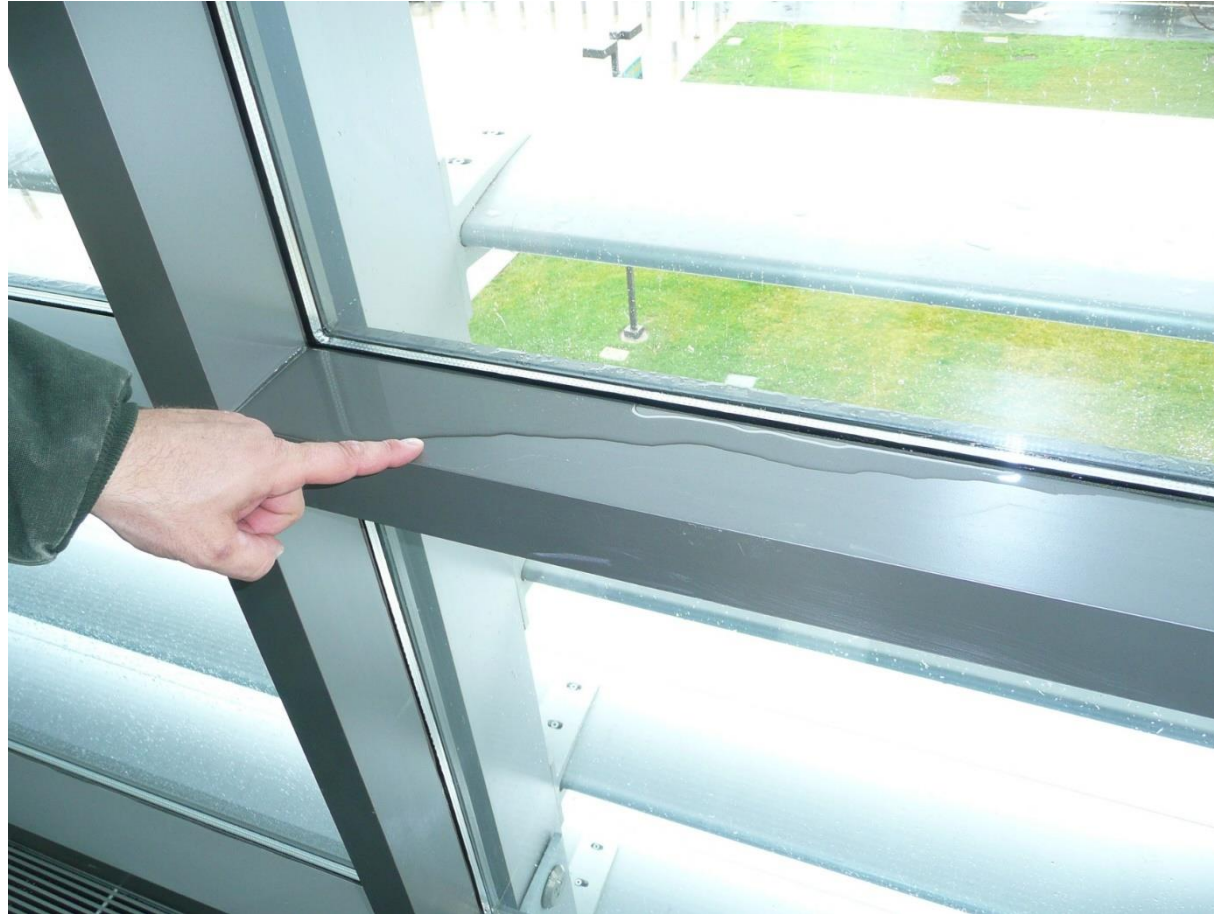
Water Testing Leak at South/East Curtain Wall

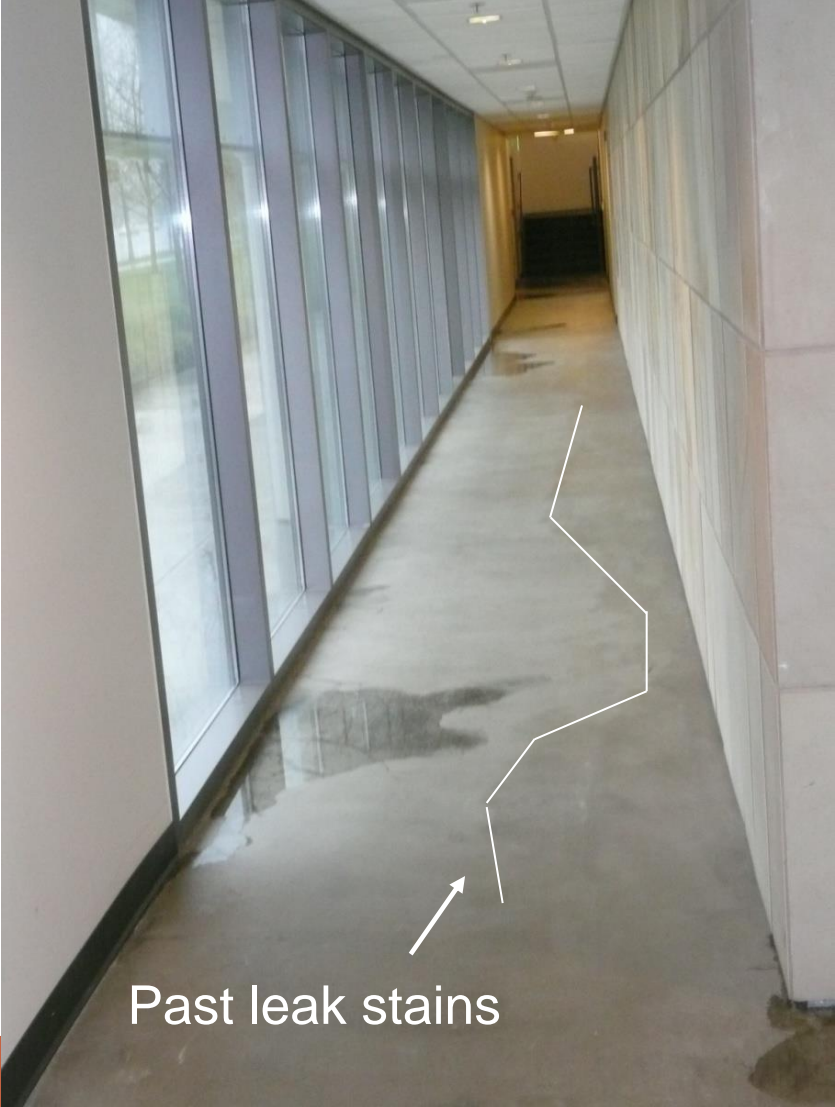
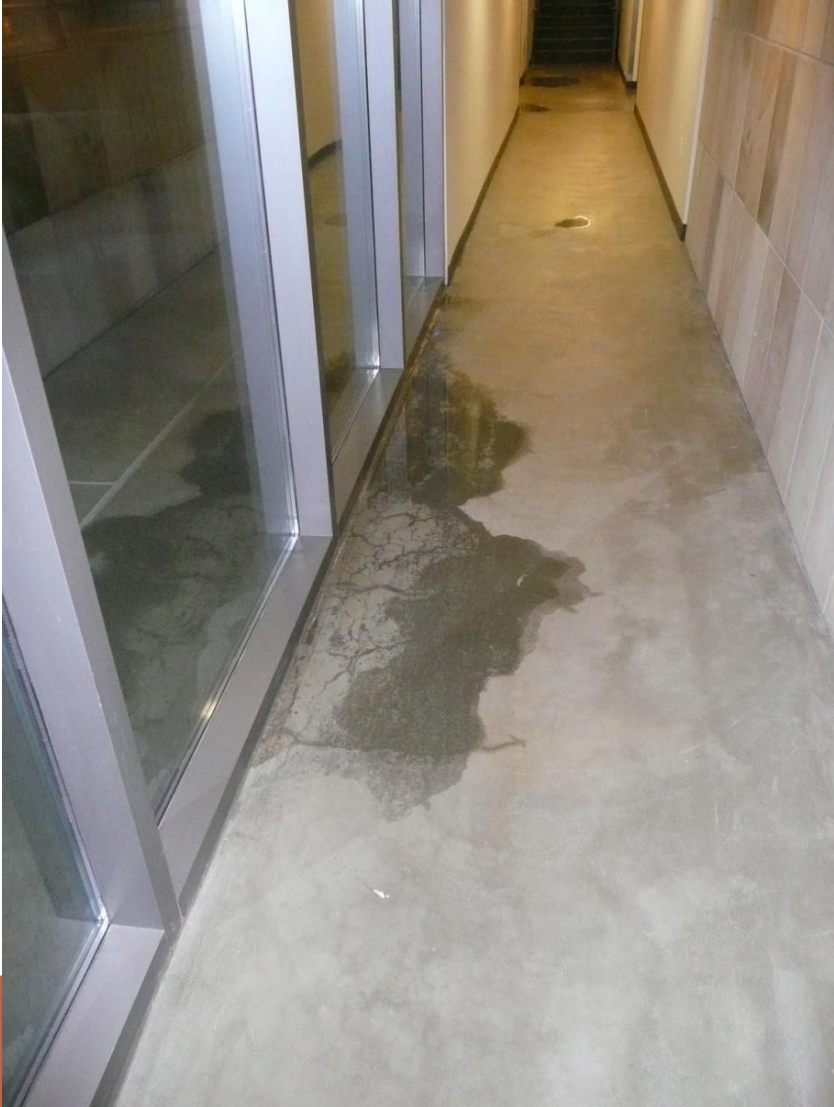
Water Testing Curtain Wall Leaks at South Wall

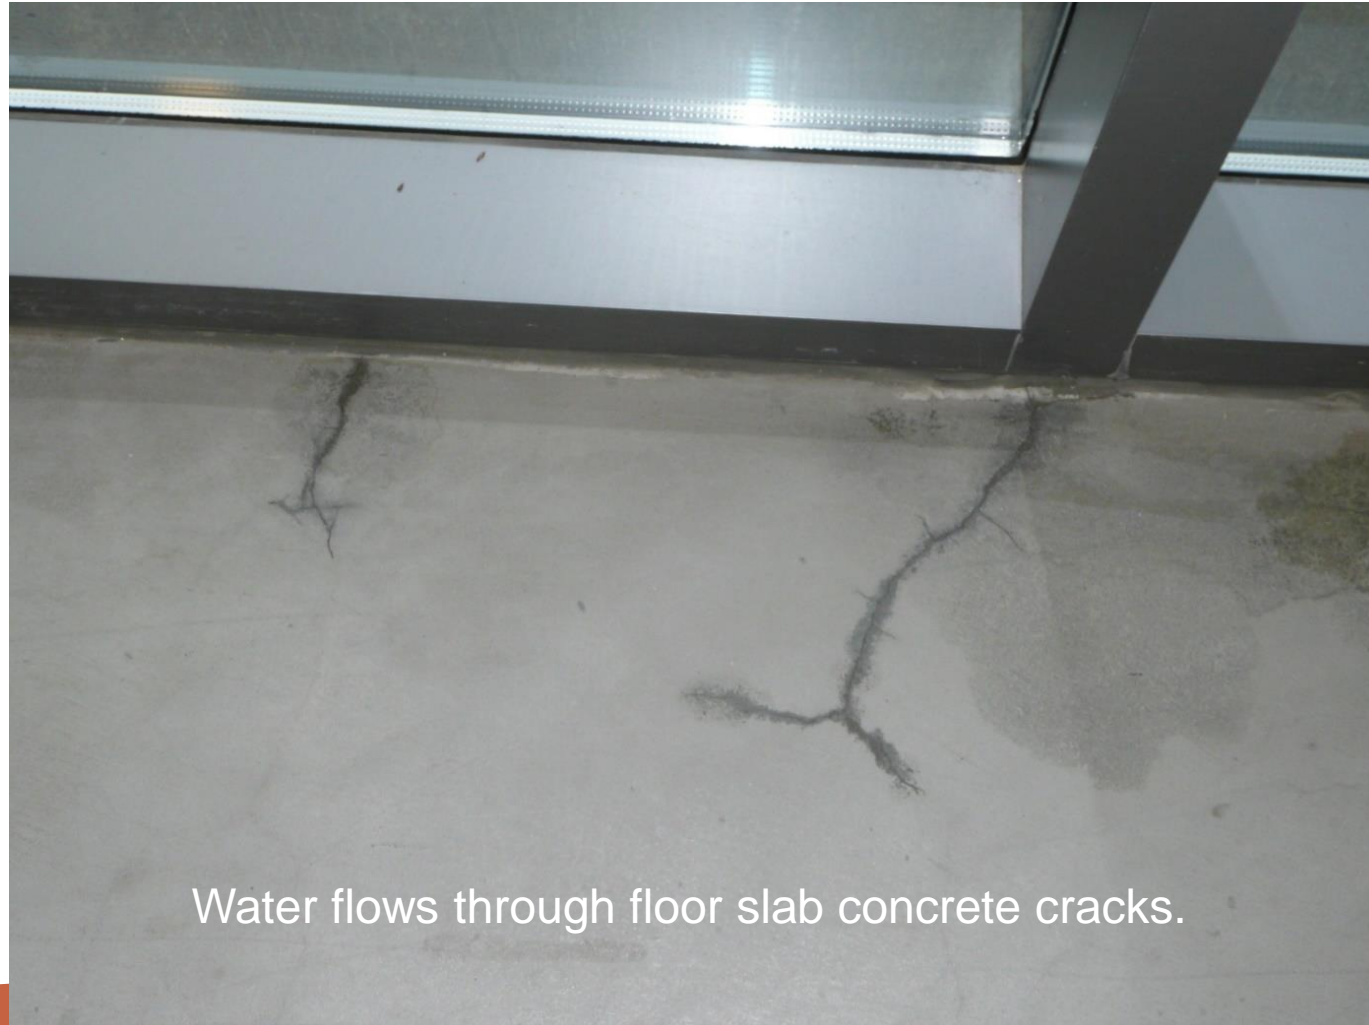
Water Testing Leaks at Slab Edge

Water flows through floor slab concrete cracks.

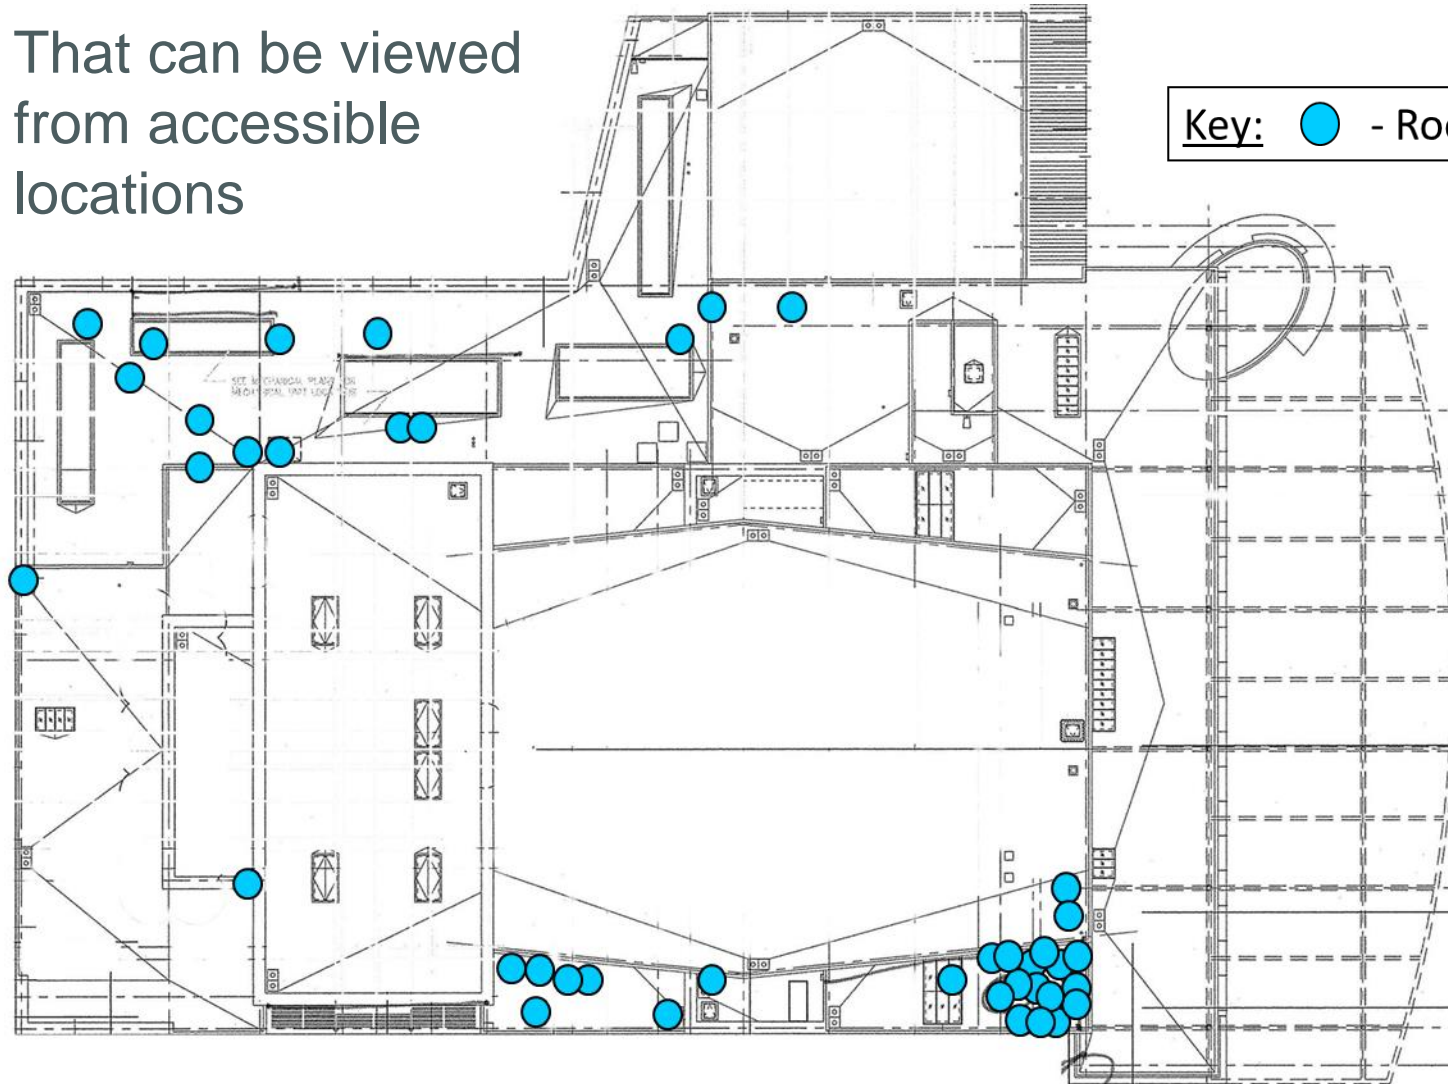
Roof Plan Leak Locations

That can be viewed
from accessible
locations

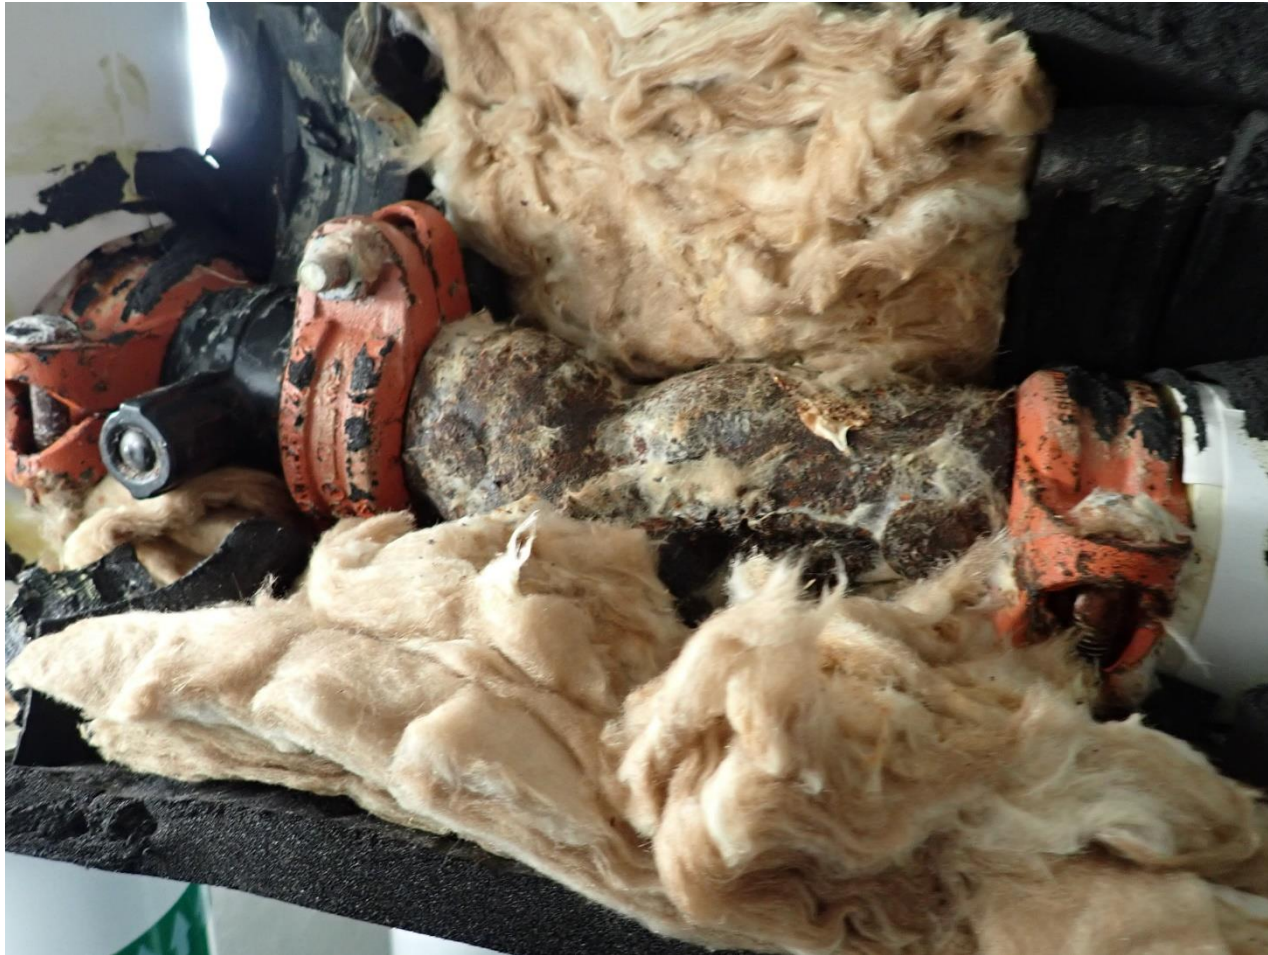
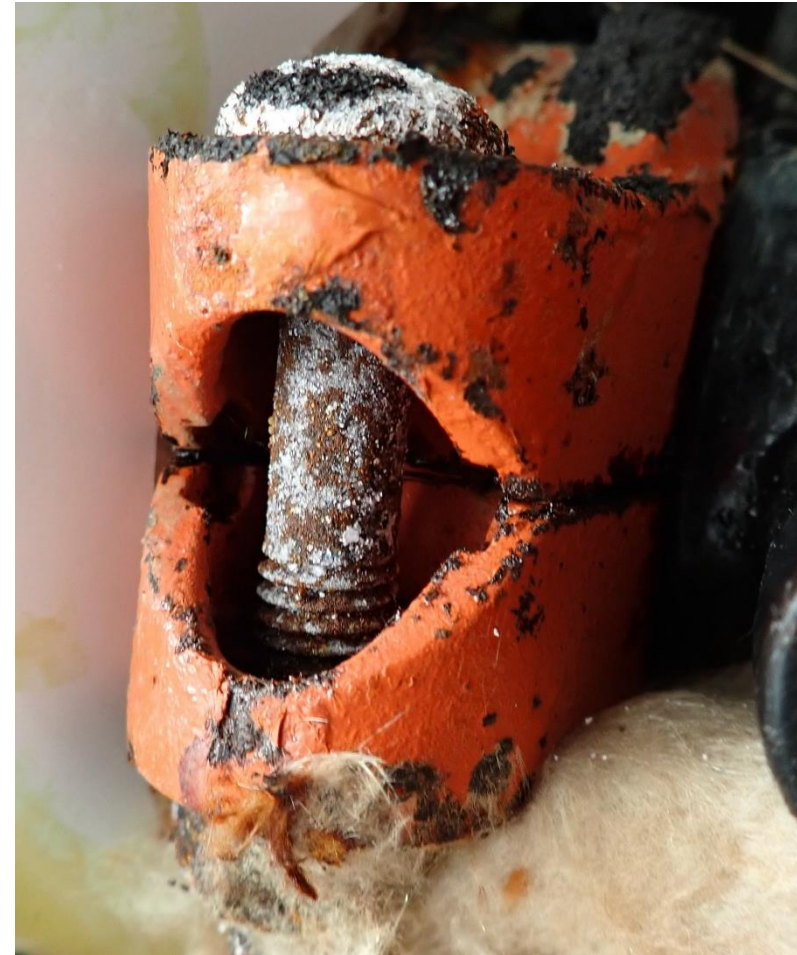
H1 – Certain chilled water grooved couplings have corroded and failed. The failures have resulted from improper installation of the insulation and vapor barrier.

Repair Recommendation: Replace all chilled water grooved couplings.

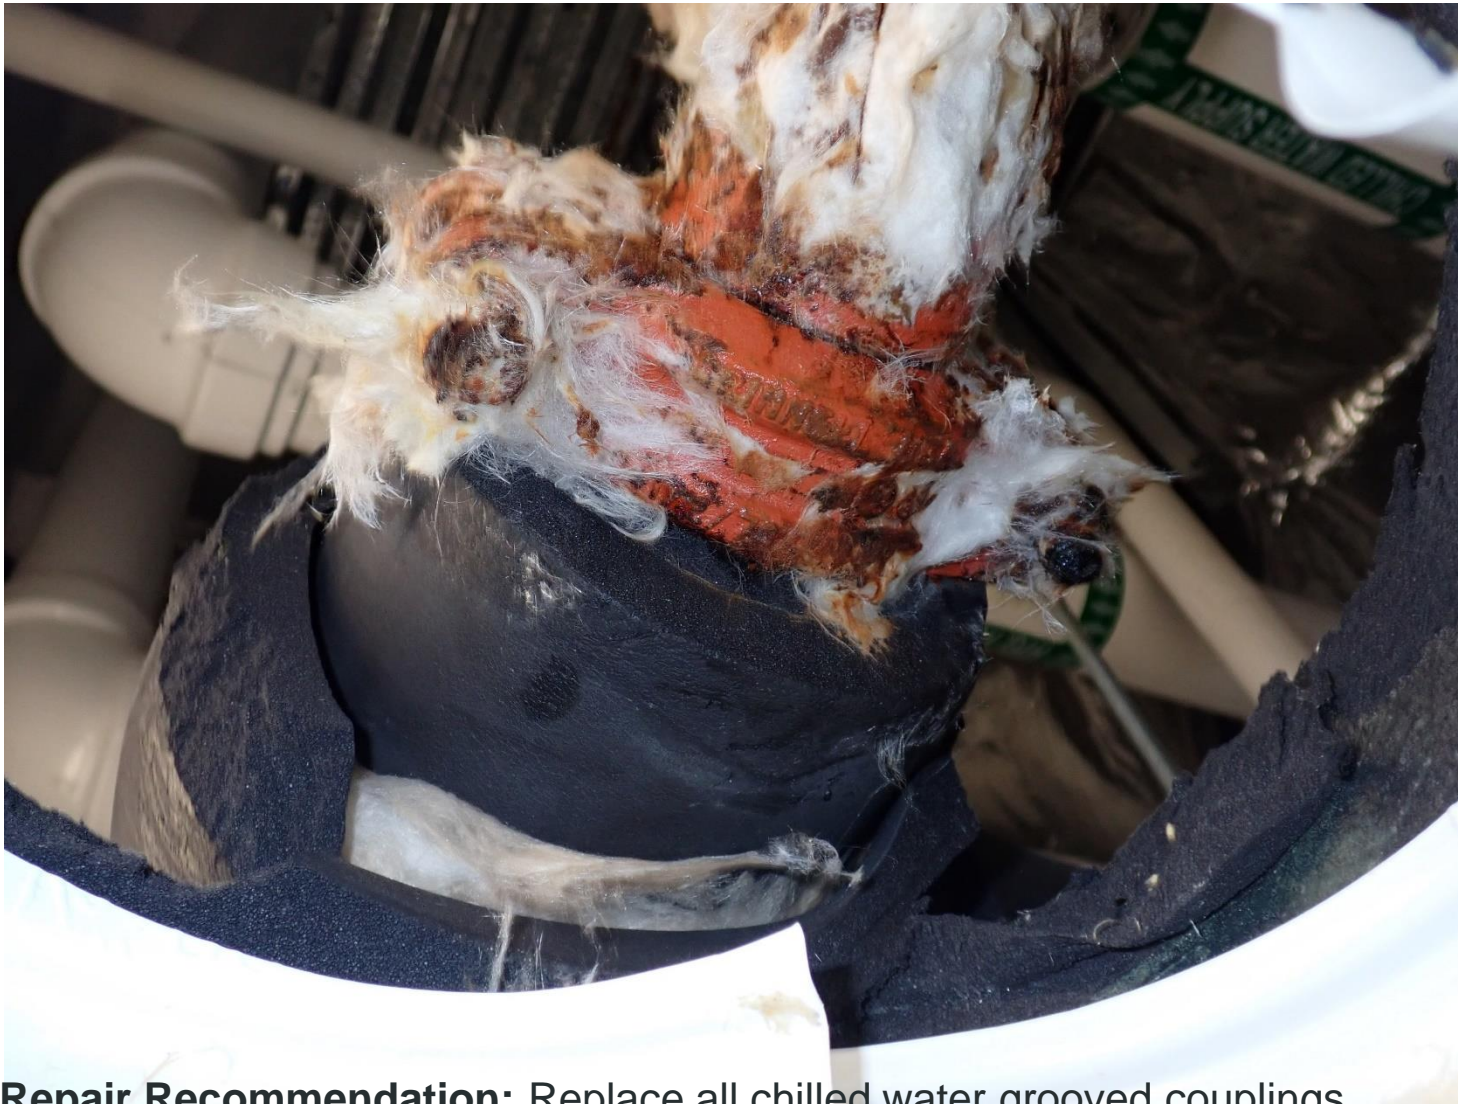
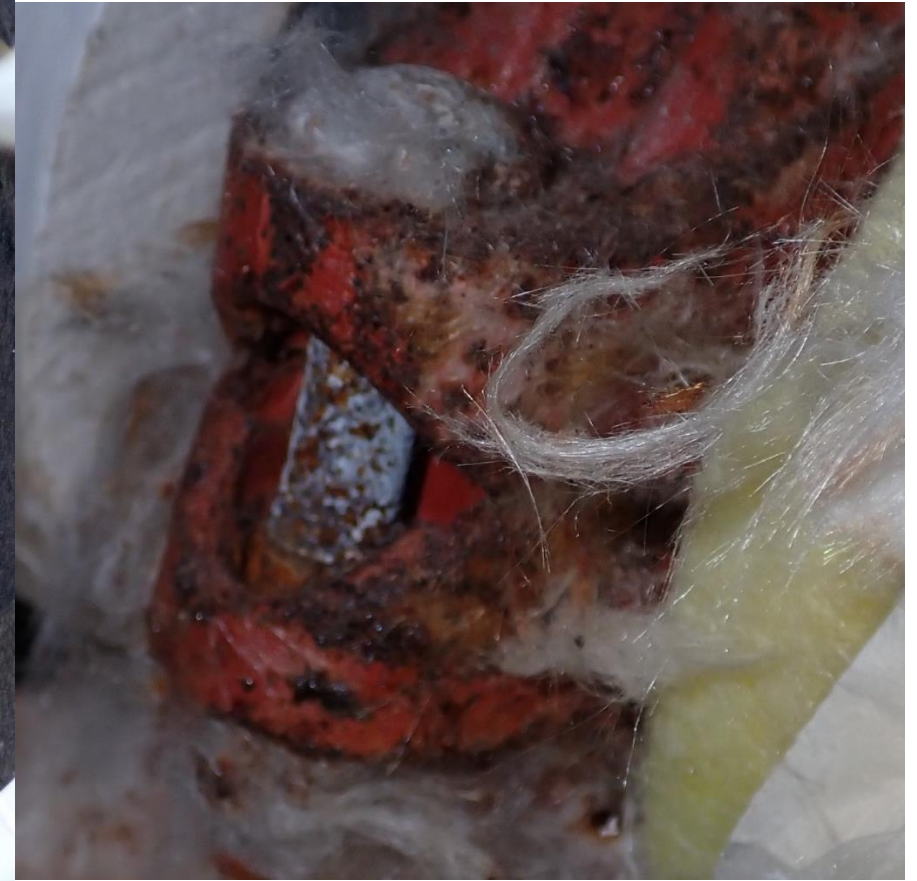
H1 – Certain chilled water grooved couplings have corroded and failed. The failures have resulted from improper installation of the insulation and vapor barrier.

Repair Recommendation: Replace all chilled water grooved couplings.

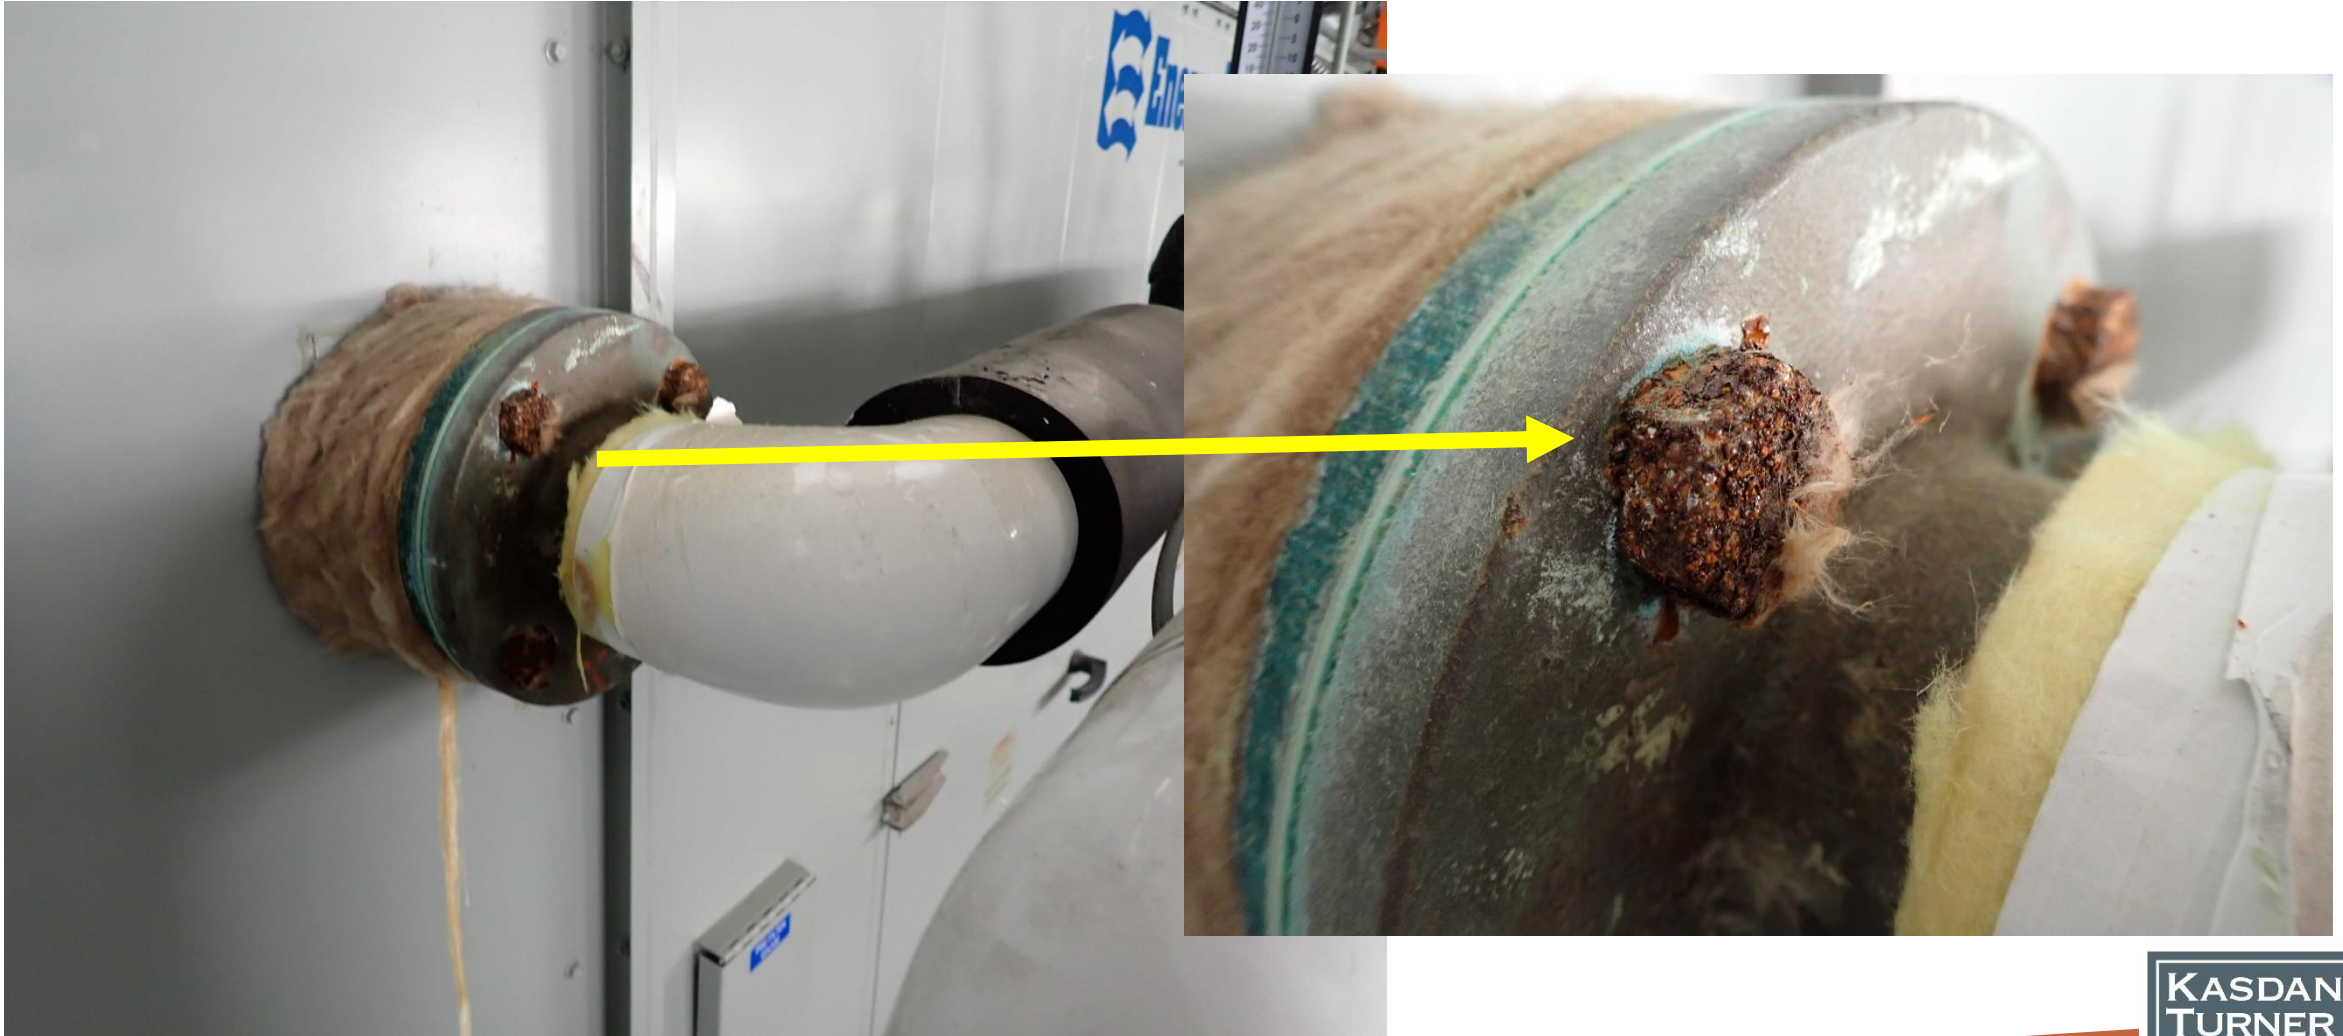
H1 – Certain chilled water grooved couplings have corroded and failed. The failures have resulted from improper installation of the insulation and vapor barrier.

Repair Recommendation: Replace all chilled water grooved couplings.

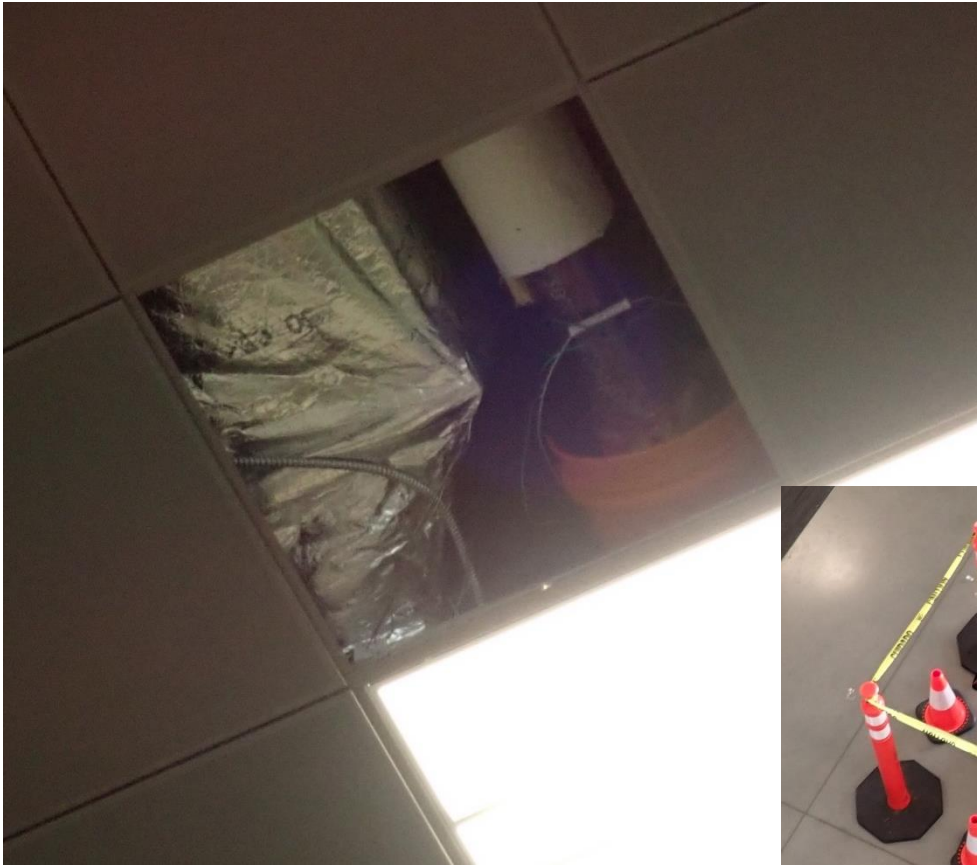
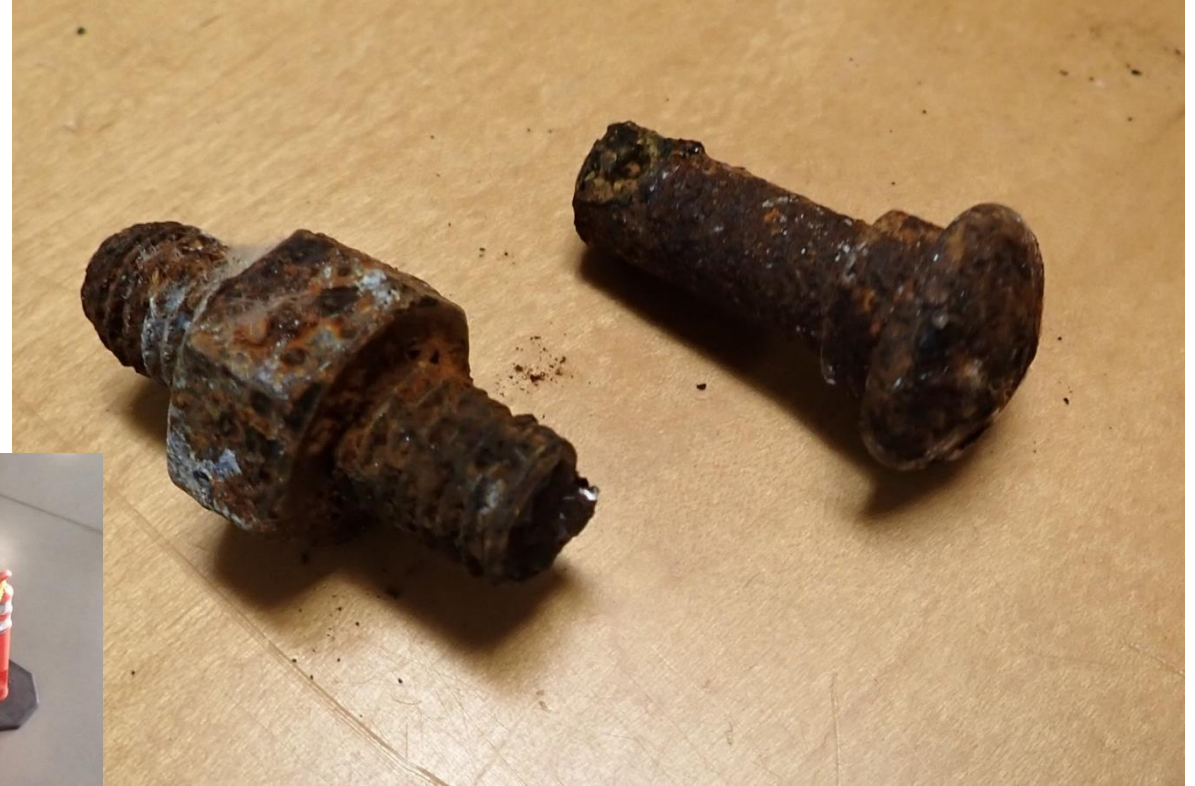
H1 – Certain chilled water grooved couplings have corroded and failed. The failures have resulted from improper installation of the insulation and vapor barrier.

Repair Recommendation: Replace all chilled water grooved couplings.

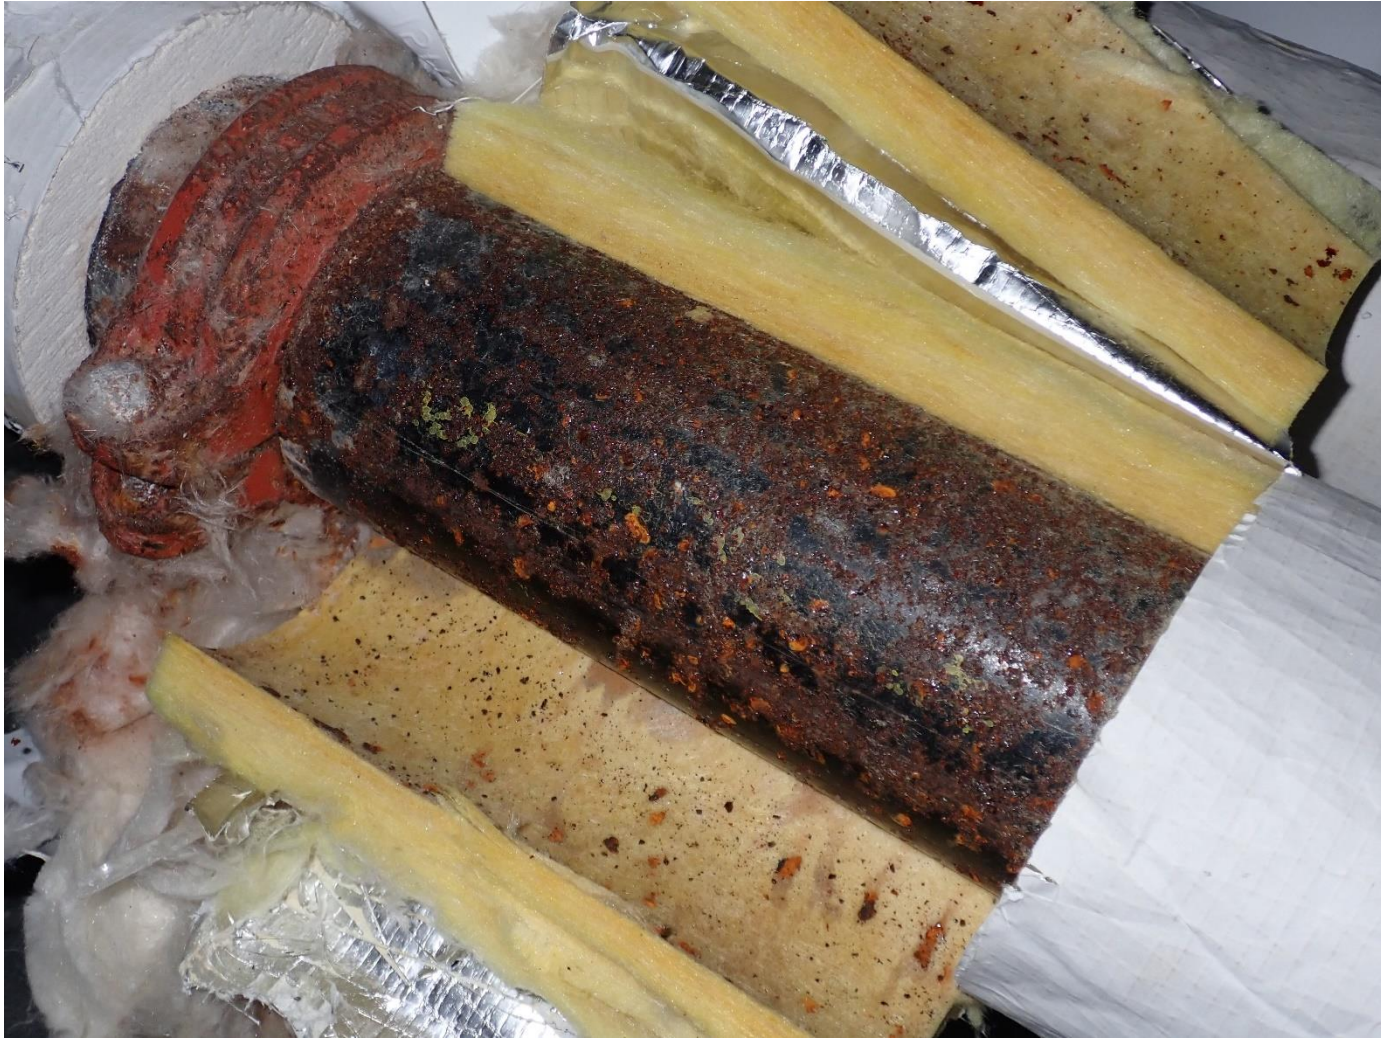
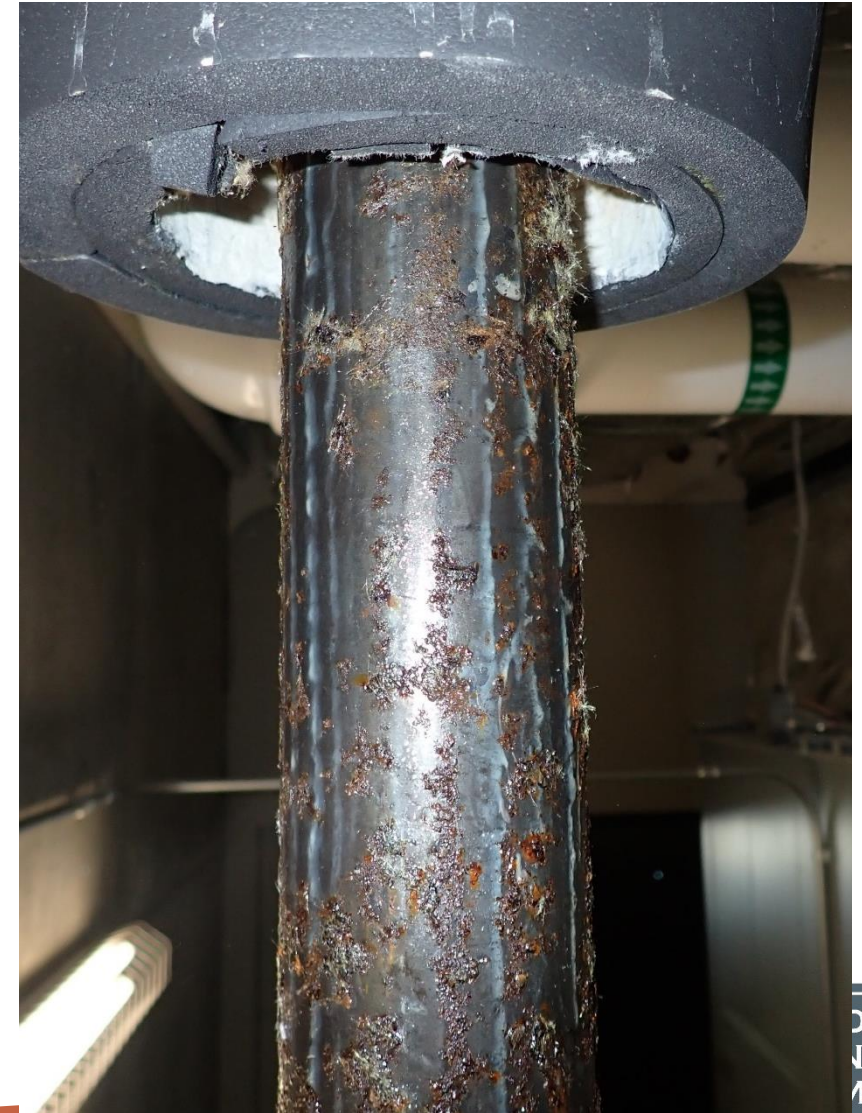
H2 – Certain chilled water piping is corroding and failing prematurely due to improper installation of the piping insulation and vapor barrier.

Repair Recommendation: Replace all chilled water piping.

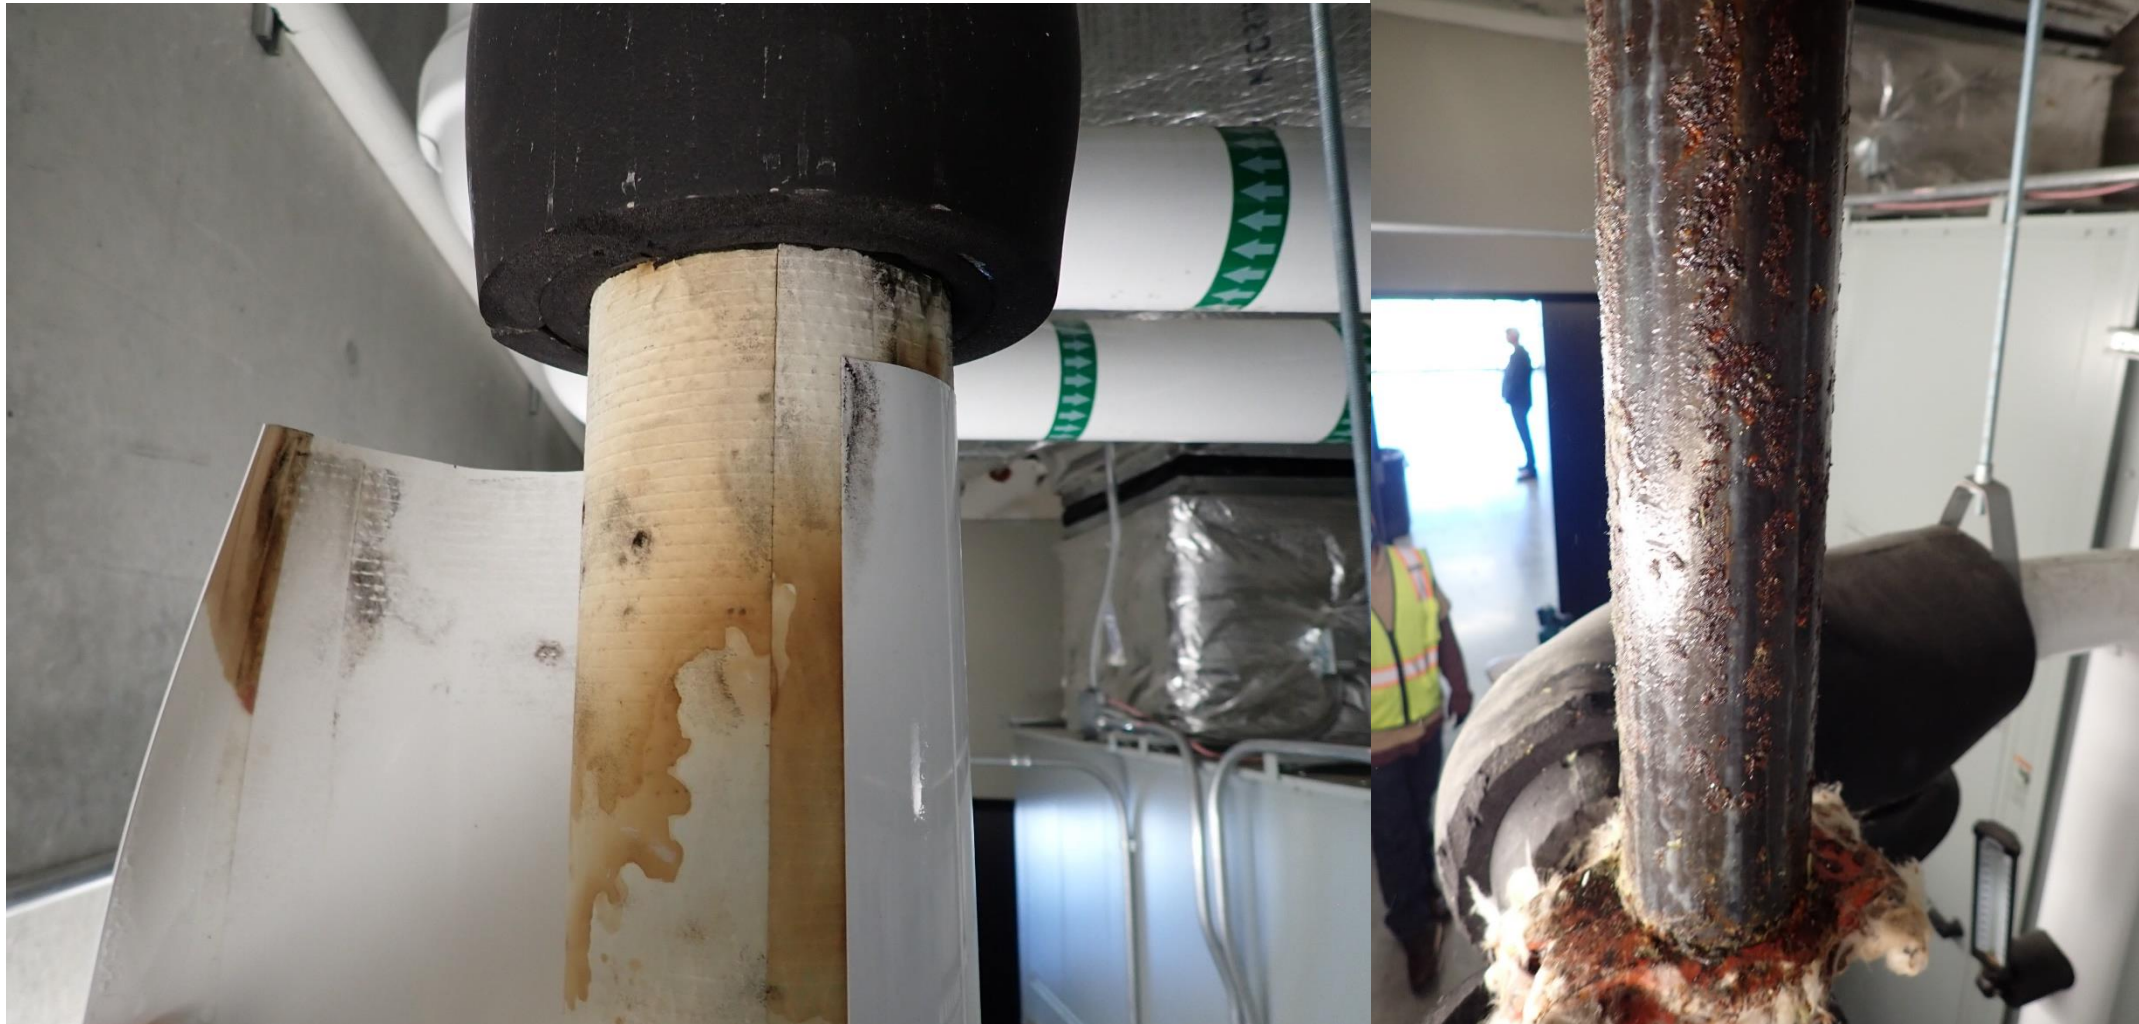
H2 – Certain chilled water piping is corroding and failing prematurely due to improper installation of the piping insulation and vapor barrier.

Repair Recommendation: Replace all chilled water piping.
