Reducing the Risk of Life Safety Issues From Construction Defects

February 4, 2023

Case Study 1 - New Library

Case Study 2 – New Performing Arts Center

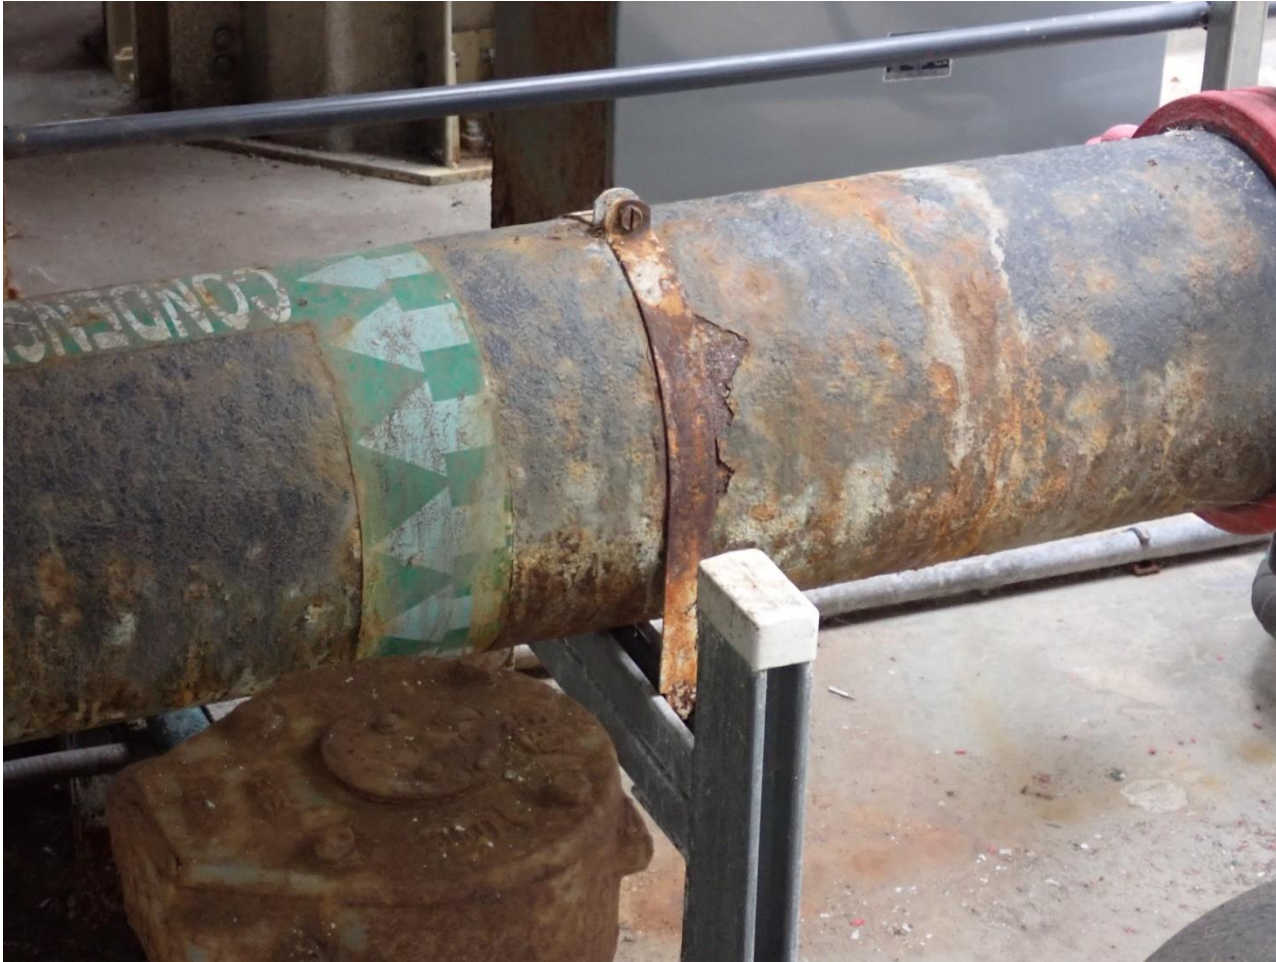
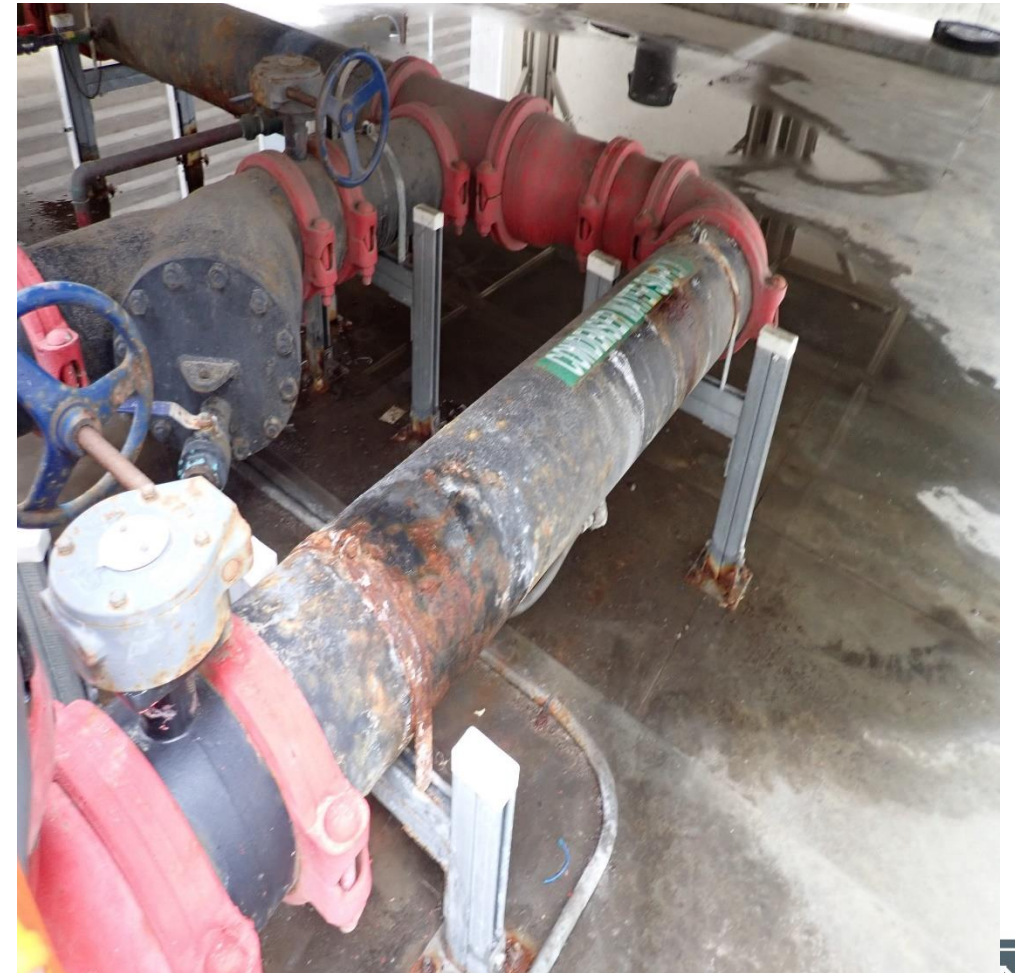
H3 – The condenser water piping is not properly protected from the elements. This has caused the piping to corrode and deteriorate.

Repair Recommendation: Treat all corroded areas and install a protective weather proof PVC jacketing. Replace piping where treatment is not effective.

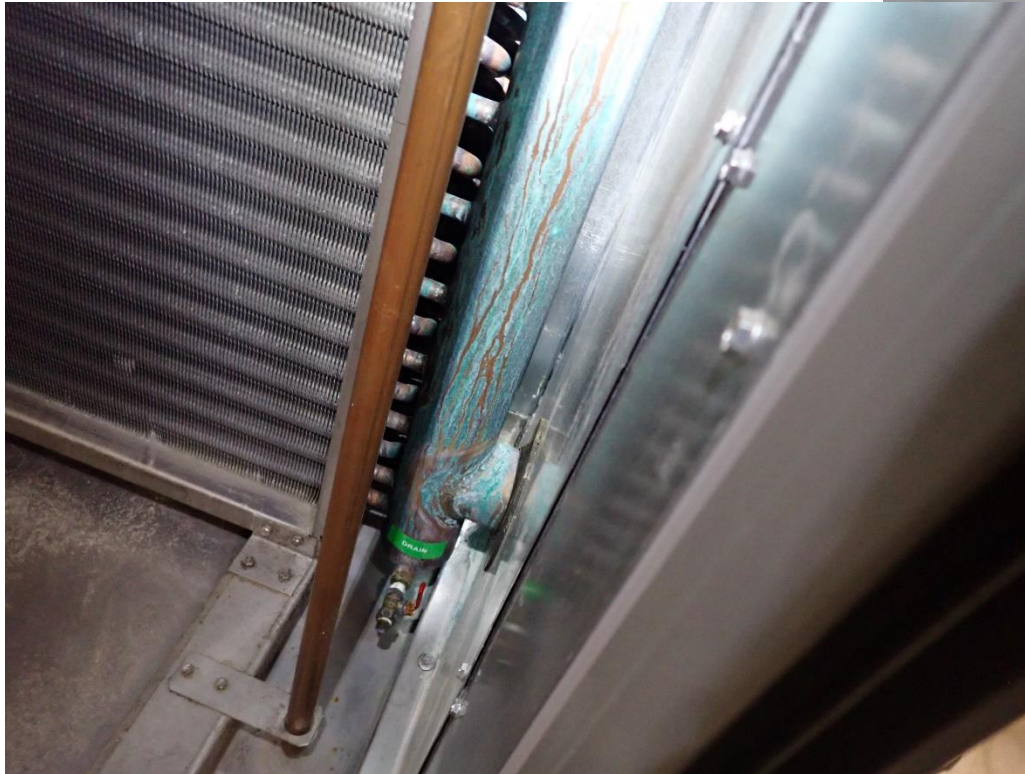
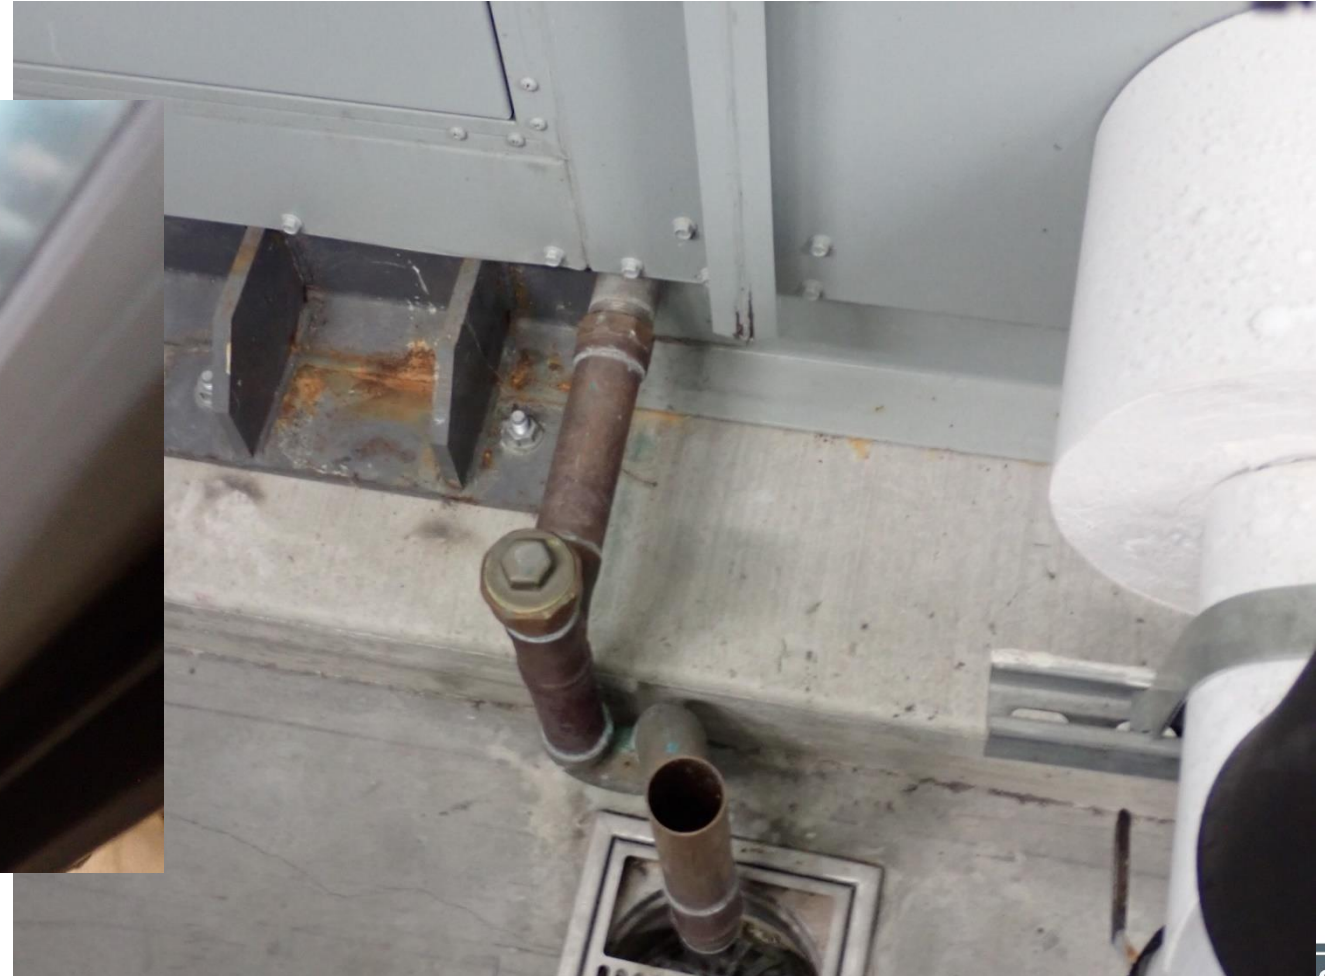
H4 – There is inadequate drainage from condensation within the air handling units (AHUs). This has caused condensate to drip out of the unit resulting in corrosion to the AHUs.

Repair Recommendation: Treat all corroded areas and install a protective weather proof PVC jacketing. Replace piping where treatment is not effective.

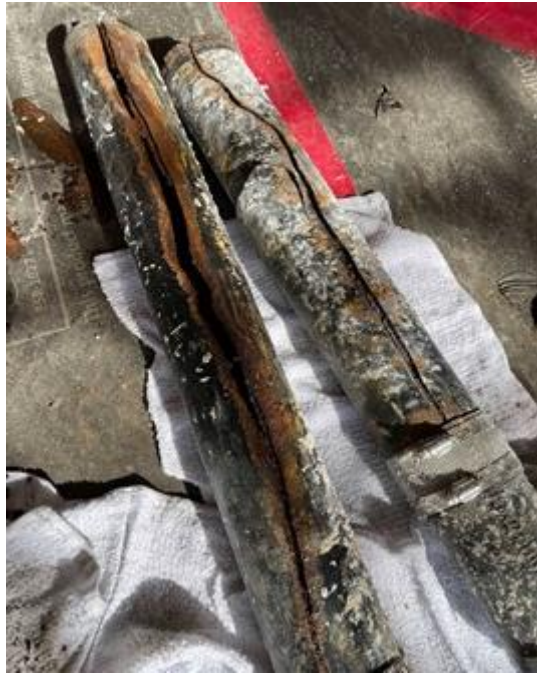
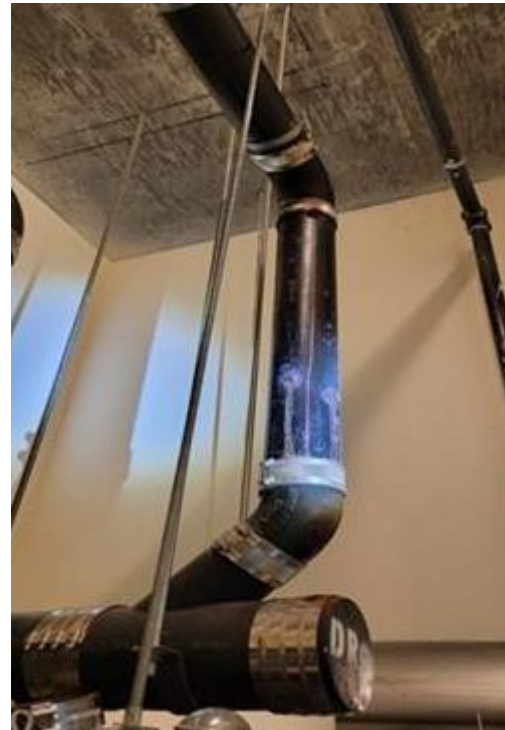
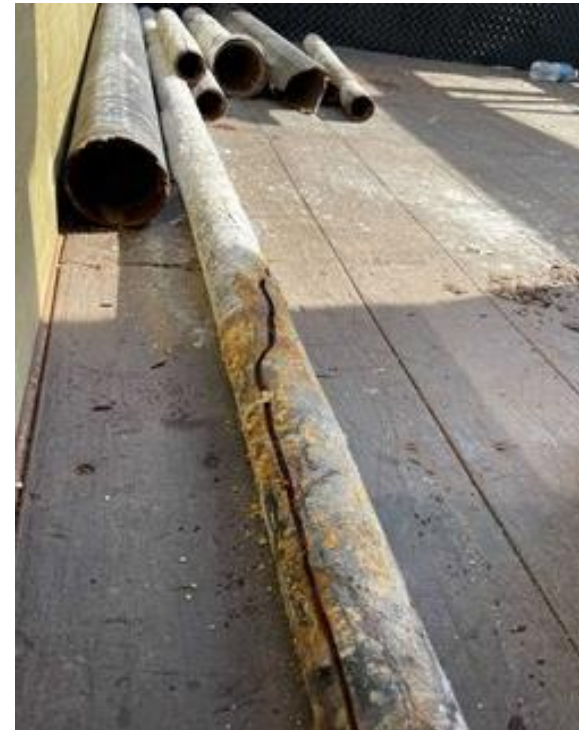
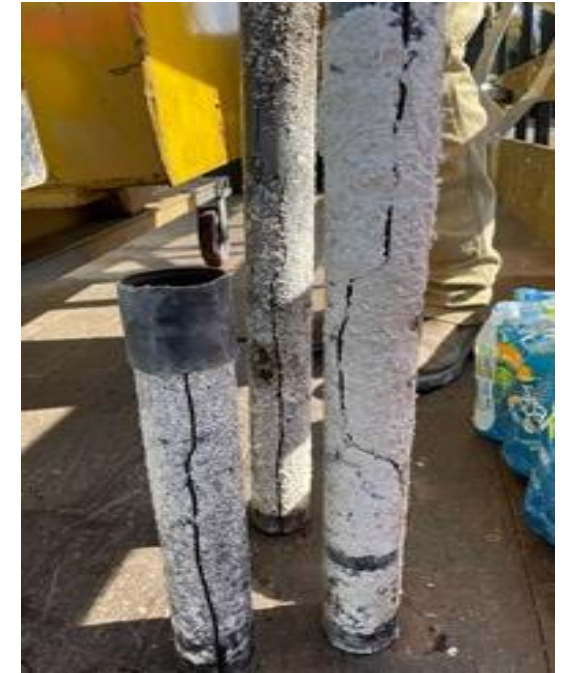
Sanitary and Storm Sewer Cast Iron Piping Failures

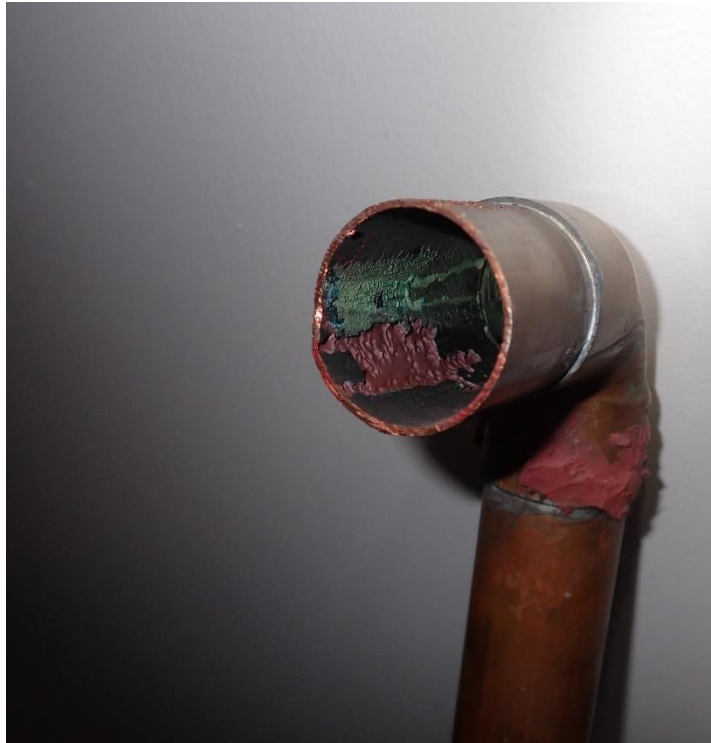
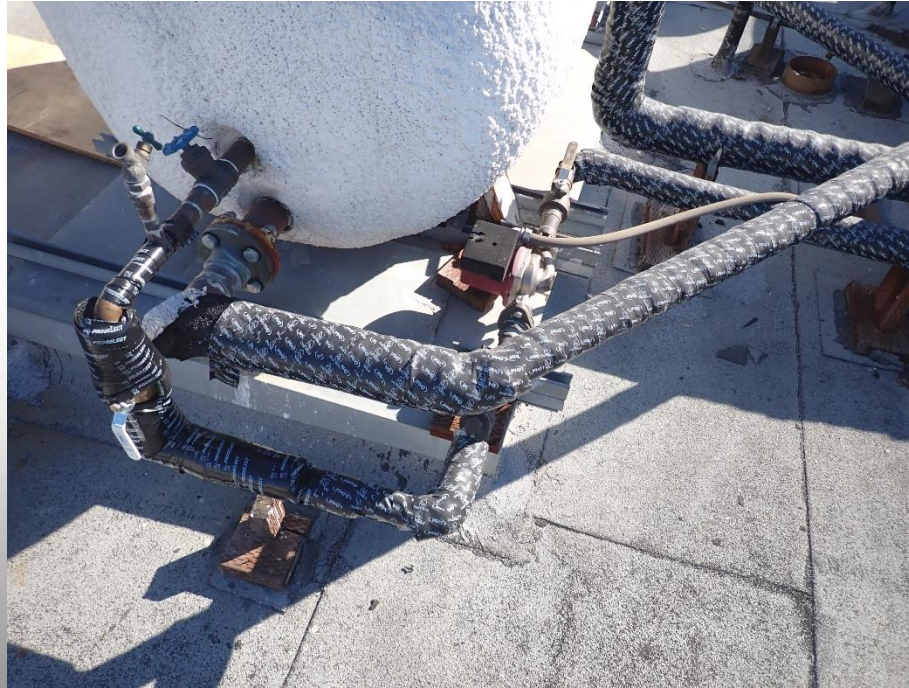
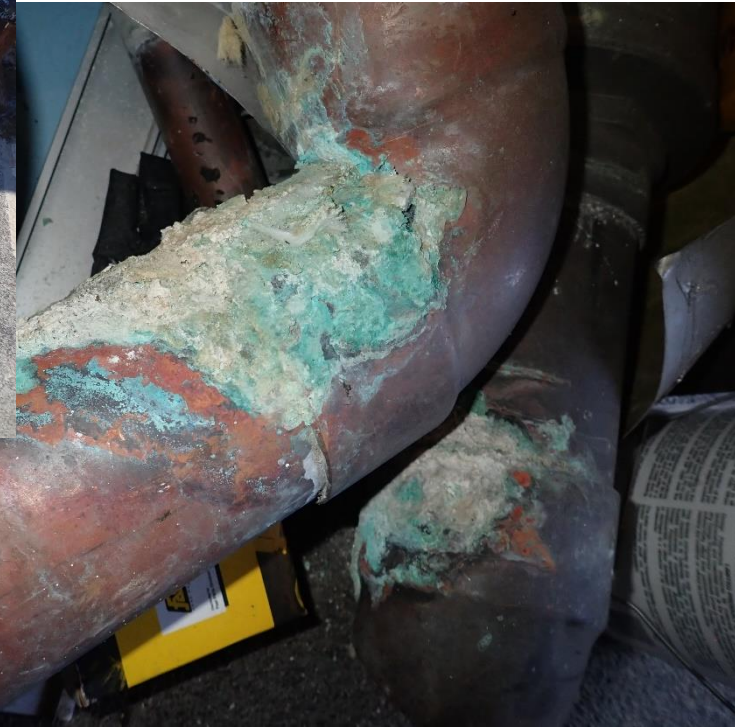
Domestic Water Systems n- Erosion Corrosion

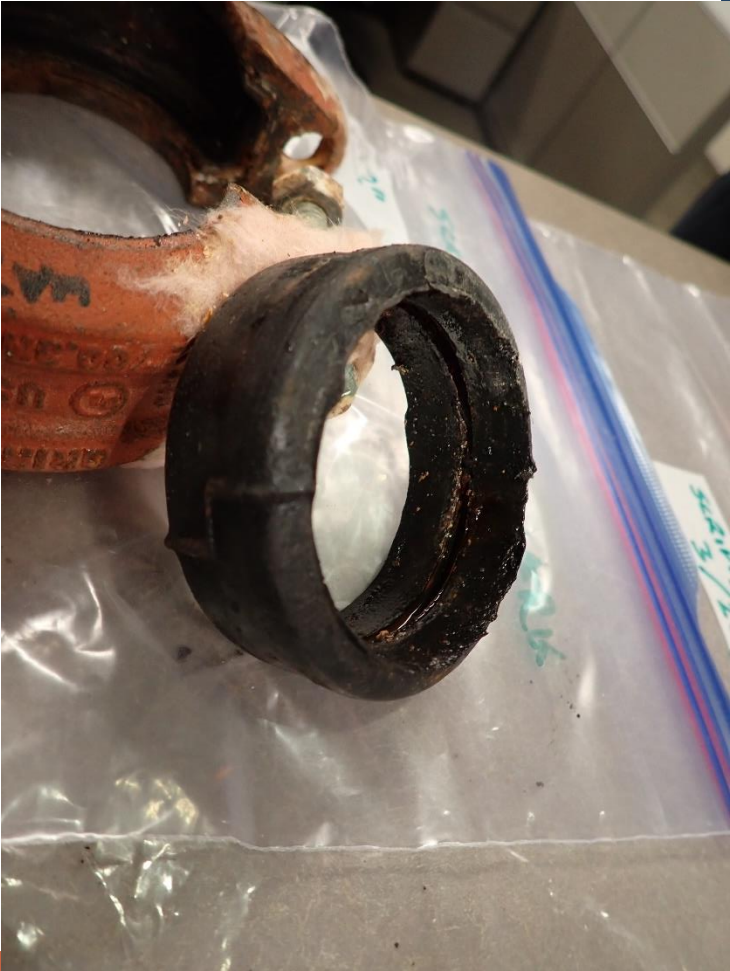
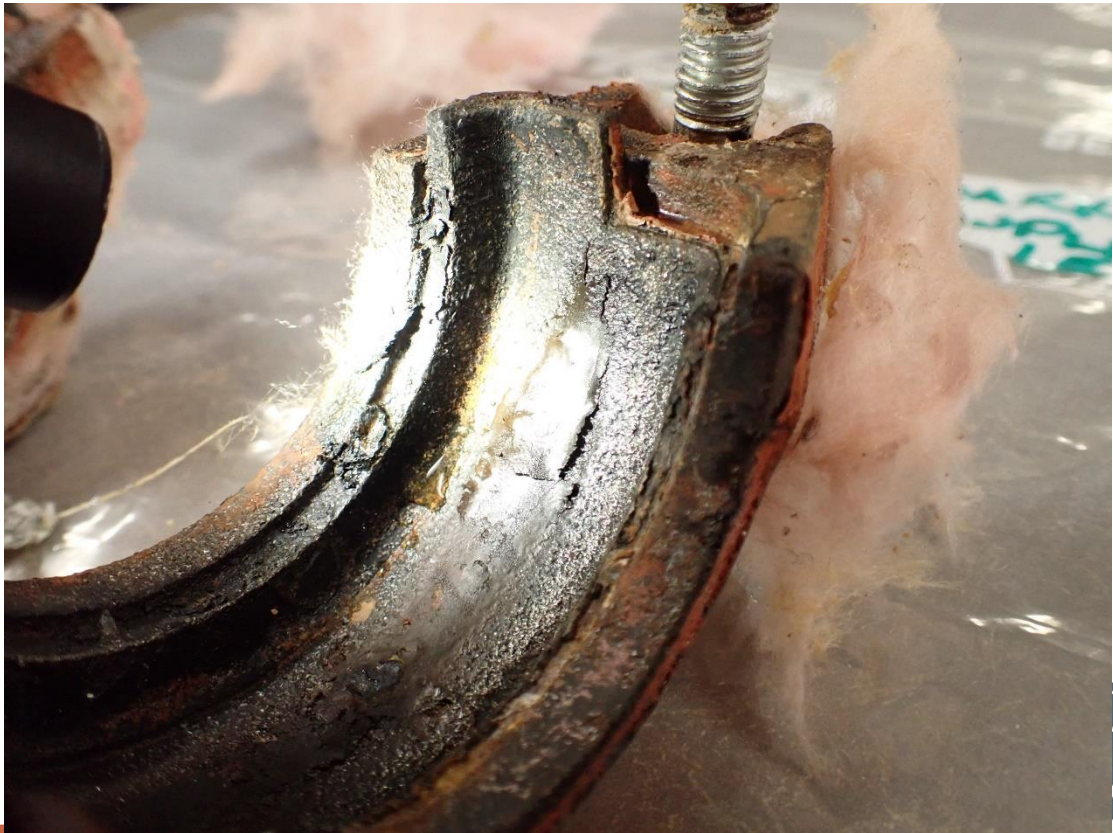
Chilled, Heating and Condenser Water System EPDM Gasket Failures

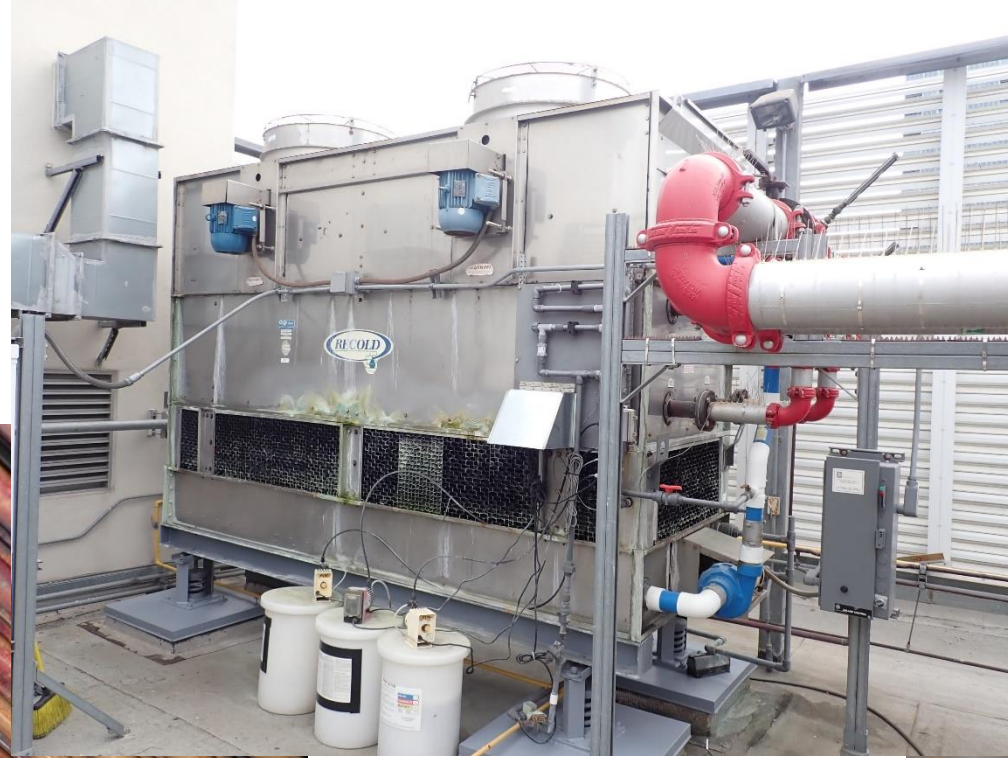
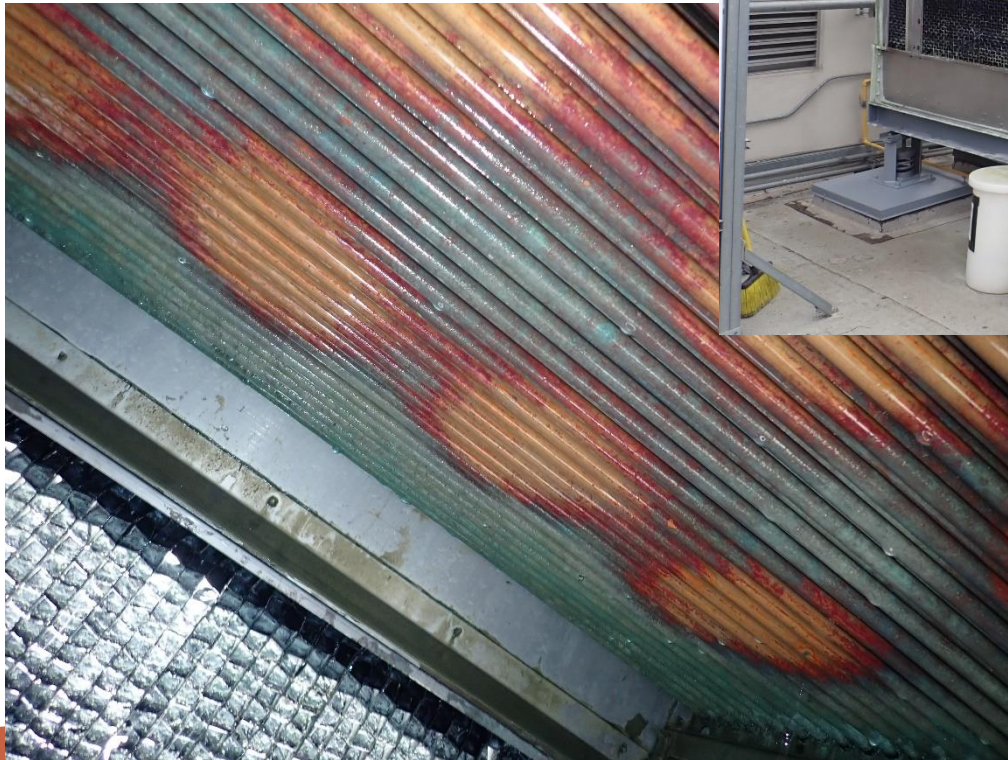
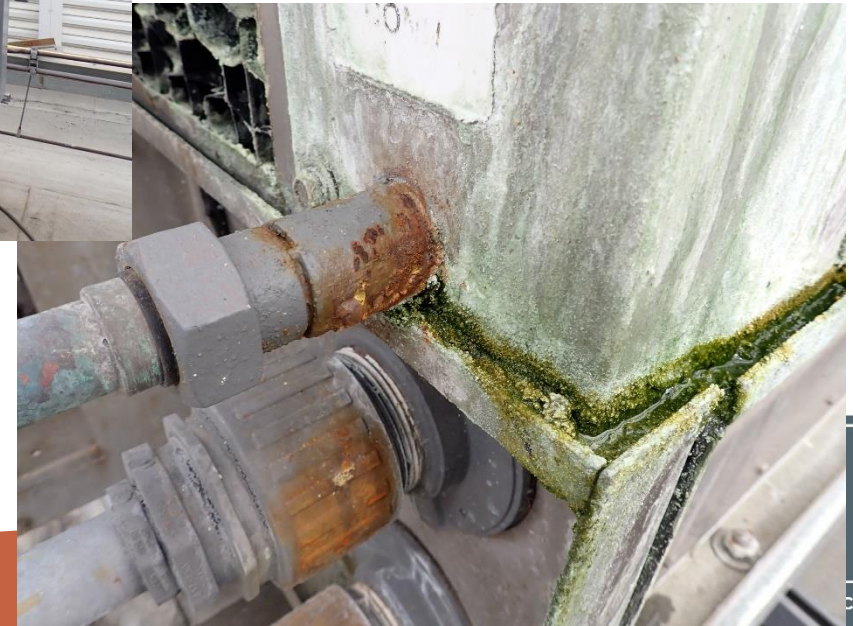
Cooling Towers and Evaporative Coolers Failures

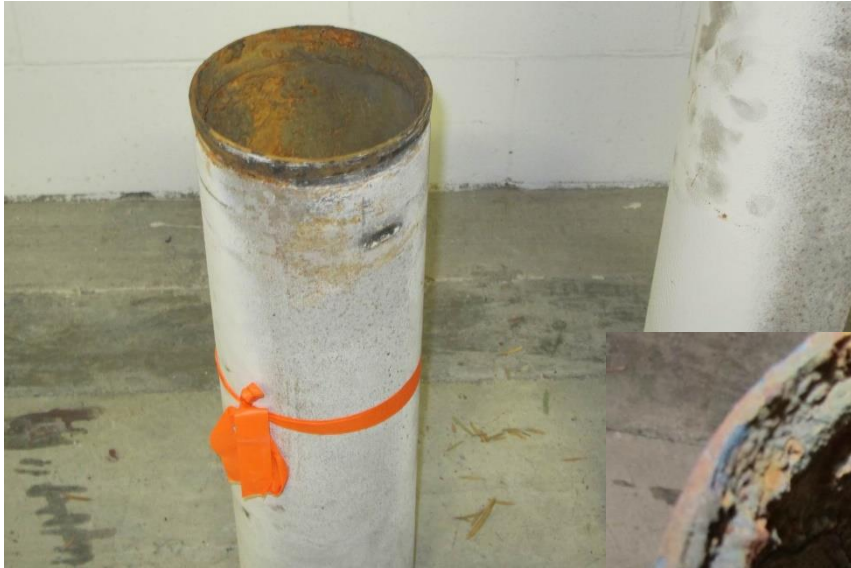
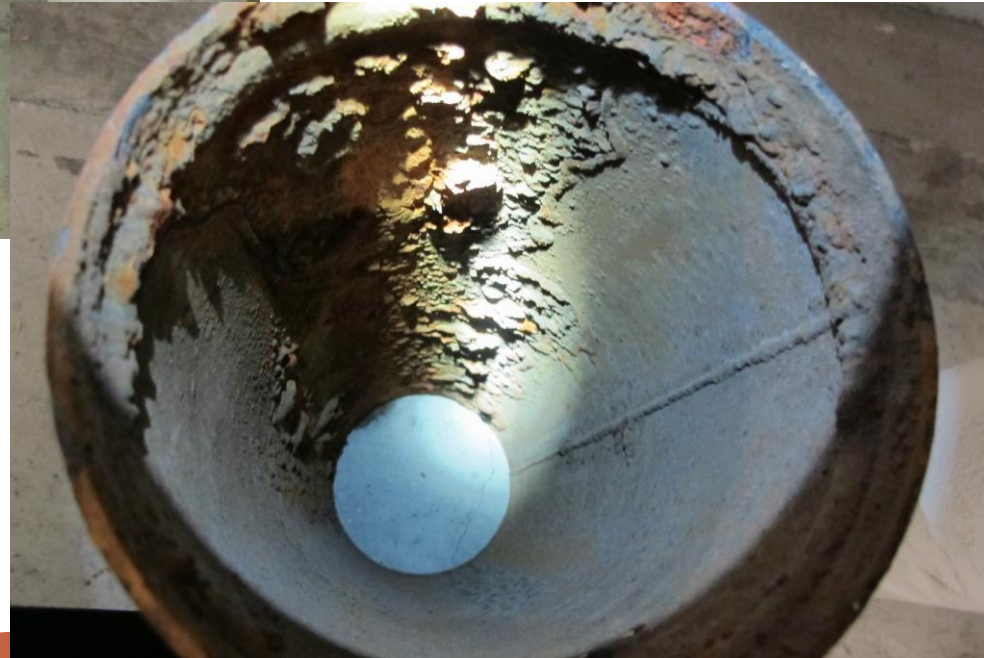
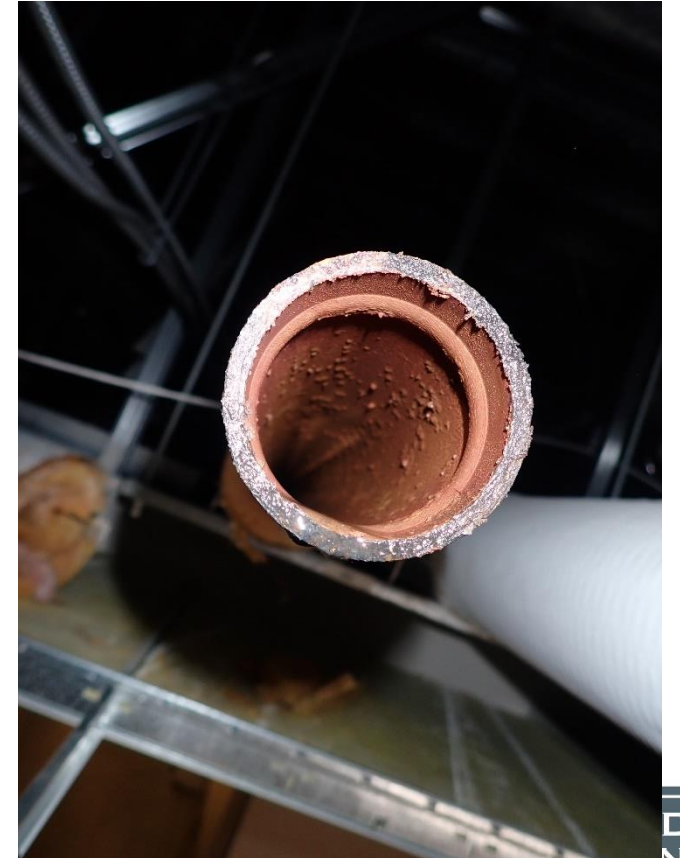
Microbiologically Induced Corrosion
