Reducing the Risk of Life Safety Issues From Construction Defects

February 4, 2023

Case Study 1 - New Library

Case Study 2 – New Performing Arts Center

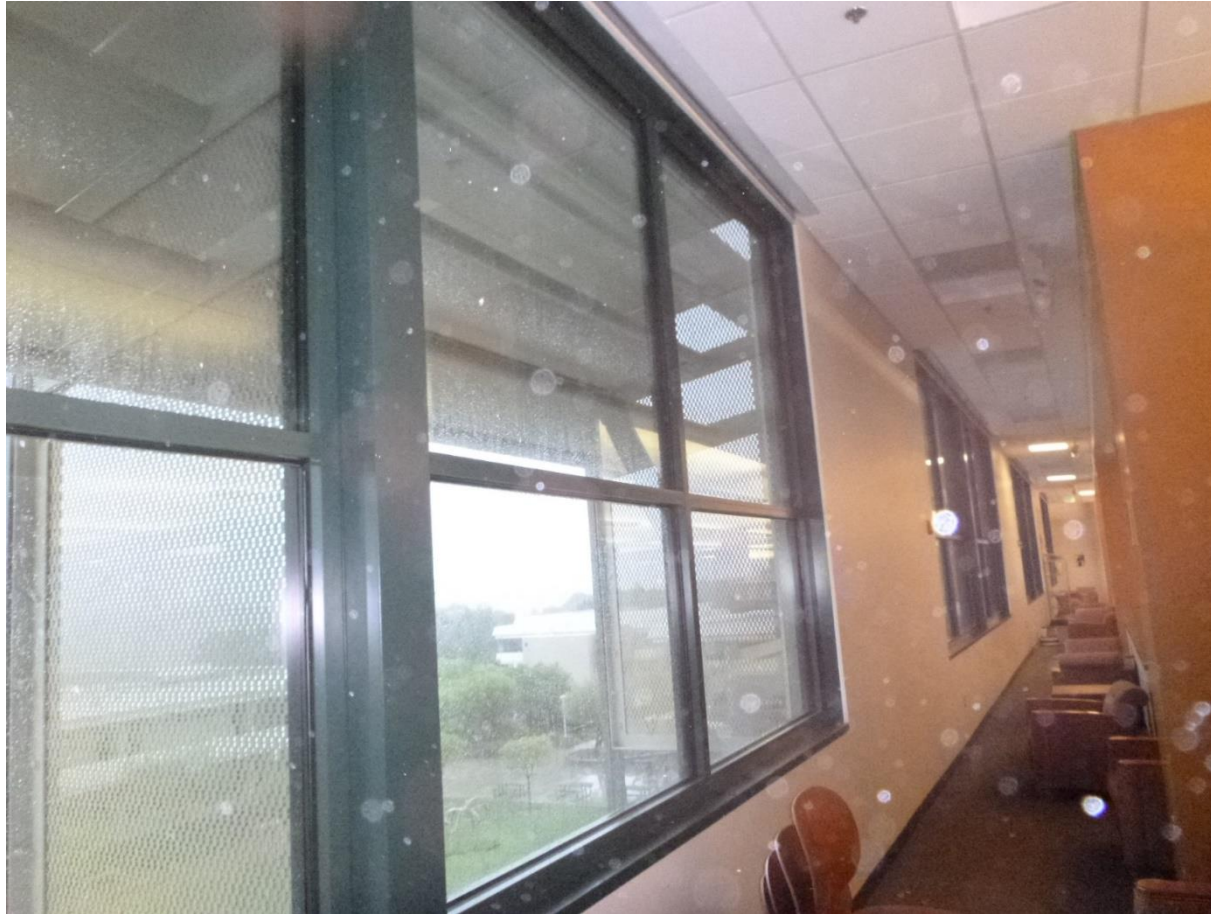
View of Typical Punched Windows

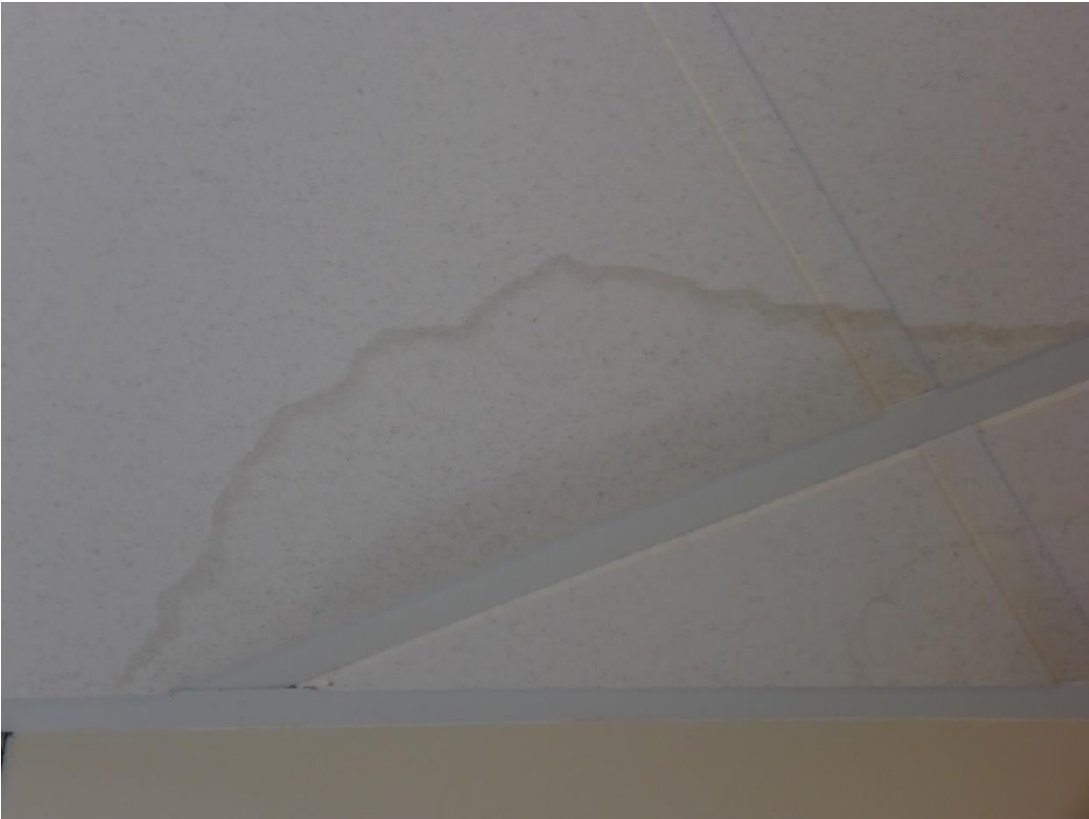
ID Location: Below Plaza Decks

Elevated Plaza Decks

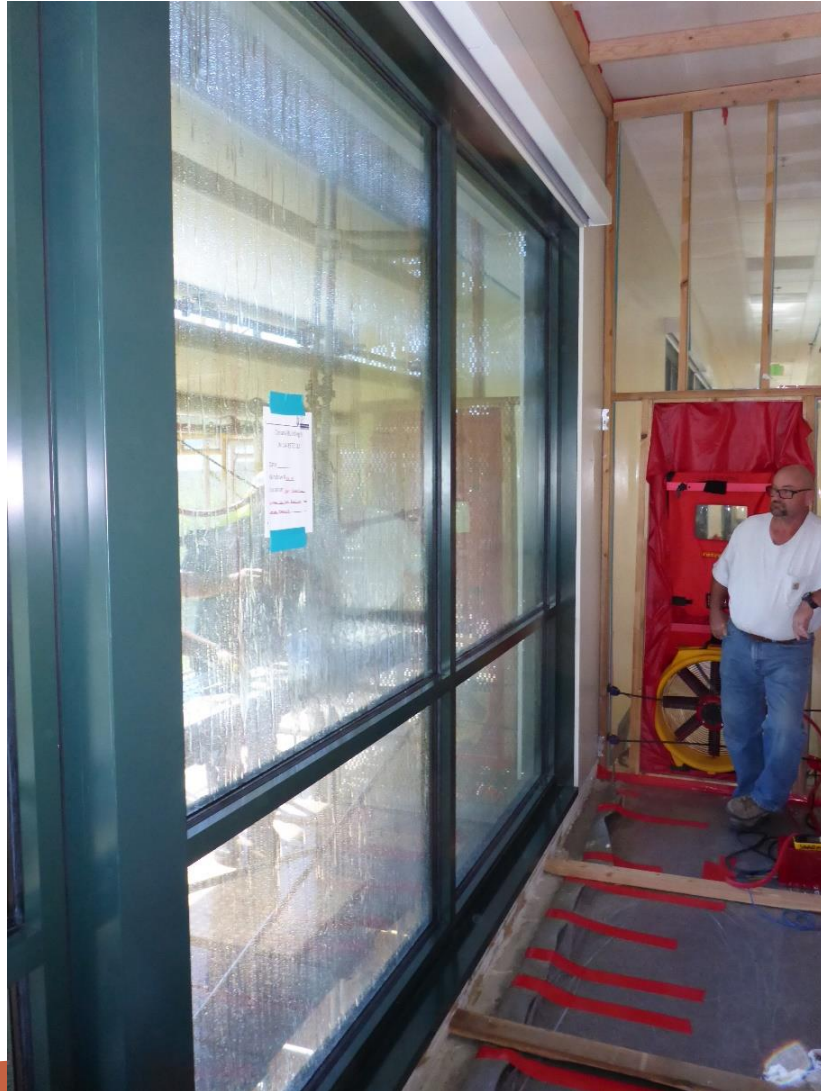
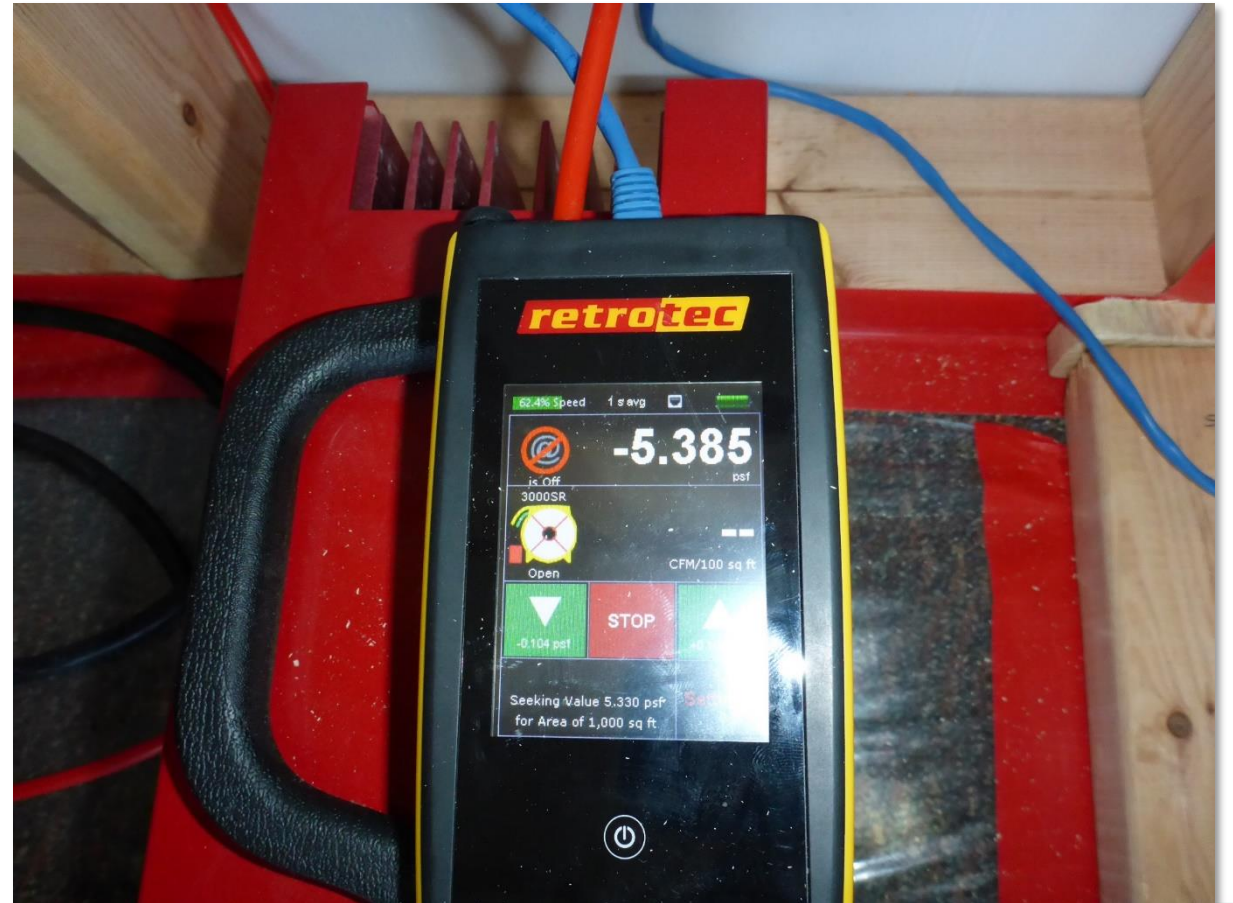
Water Testing in Progress

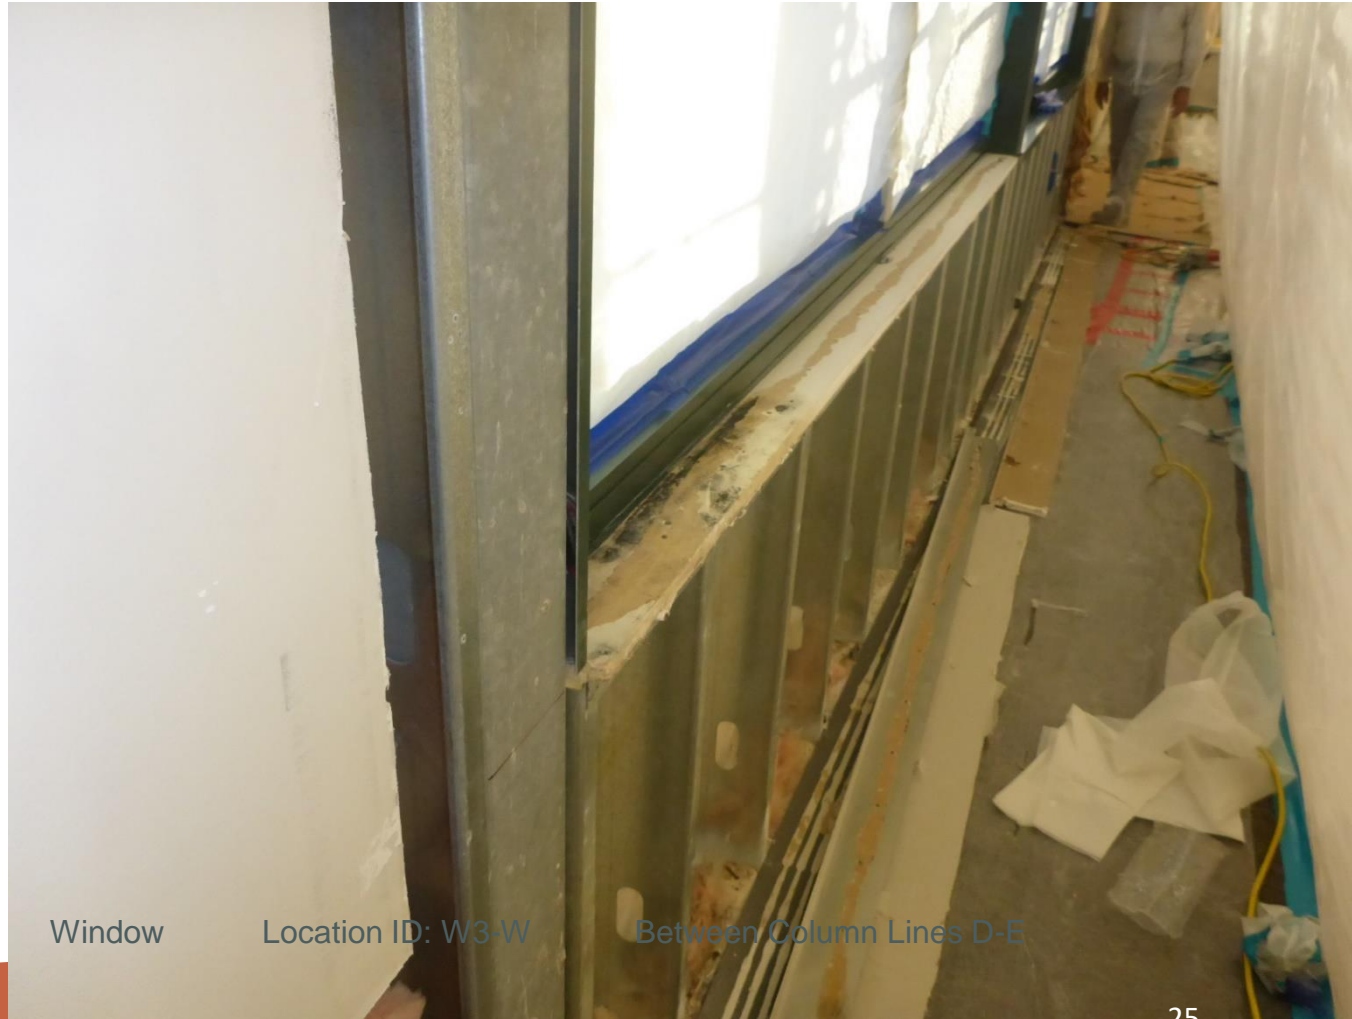
Location ID: W3-W

Mold Abatement – Growth at Window Sill

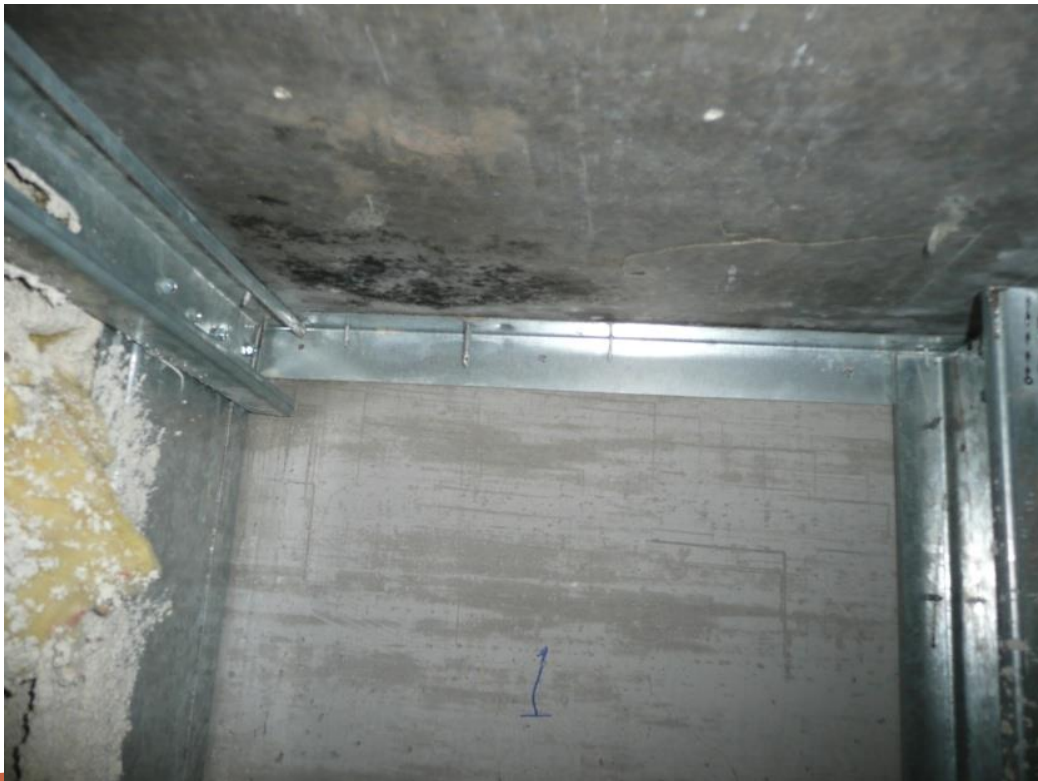
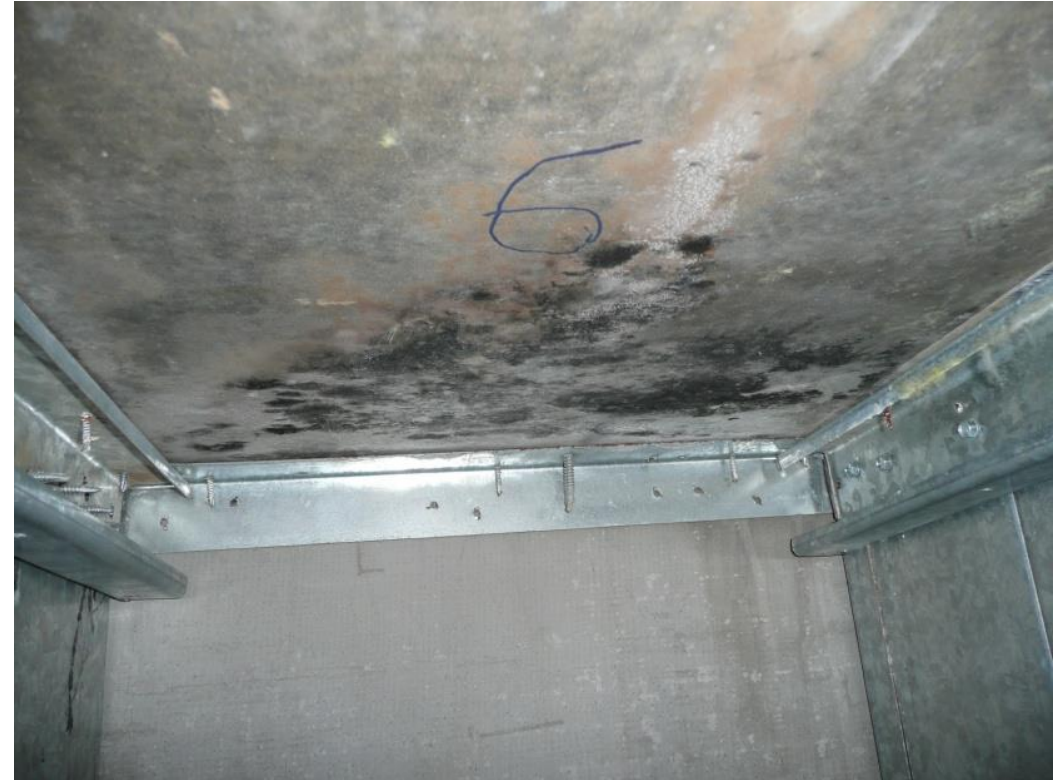
Biological Growth Under Recessed Sill
